febi 26775

To fit:
Mercedes Benz CDI engines

Belt tensioner

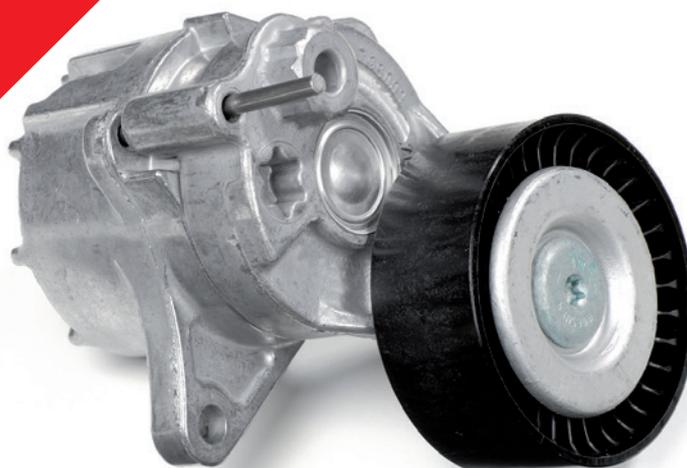
For design reasons, when the vehicle is driven with the original version of the belt tensioner installed (ref. no. 611 200 04 70), noise may occur (The manufacturer has now replaced this version).

The noise is generated because the spring is too long and makes direct contact with the base of the housing (1). Only the spring's torsional characteristics are important for this application (2), (6).

The noise is caused when the spring touches the cast-in hollow pin (3) and the base of the housing (4).

febi supplies the belt tensioner febi 26775 (ref. no. 646 200 05 70) for the free aftermarket.

A highly wear-resistant plastic bushing (5) distance the spring from the base of the housing and prevents metal-to-metal contact where the spring is located. Since only the springs's torsional characteristics are important the height has been reduced (6).

The spring makes contact with the plastic bushing (7) and is therefore prevented from touching the base of the housing. No noise can therefore occur. In the new version (8), a steel pin has been cast in the base of the housing in order to center the spring.
