febi 31253

VW Polo (9N), Seat Ibiza (6L), Skoda Fabia (6Y/5J)

## Suspension arm bush

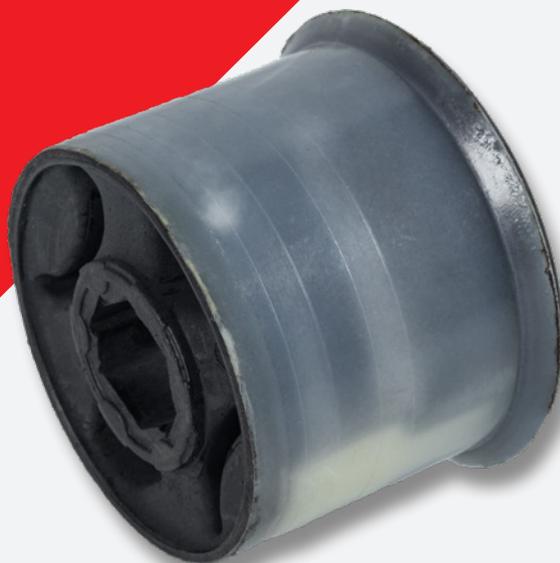
Knocking or creaking noises occur in the axle area when driving.

Vehicle manufacturers design suspension arm bushes which are often not strong enough. Their lifetime is also shortened by poor road and weather conditions. The version originally fitted (repl. No. 6Q0 407 183 A) had two rubber bars (Fig. 1) which could tear under unfavourable loads (Fig. 2). This variant has been withdrawn from service at VW and replaced.

febi bilstein recommends using the new suspension arm bush febi 31253 (repl. No. 1K0 407 183 E). The strengthened suspension arm bush has four rubber bars and can withstand large loads even under poor road surface and weather conditions (Fig. 3).

The fitting position of the suspension arm bush has changed. Where previously one of the rubber bars determined the fit, it is now necessary to pay attention to an exact fitting position. Please refer to the febi information sheet included in the box for details.
