Various Volkswagen, Audi, SEAT and Škoda models.

Oil Filter

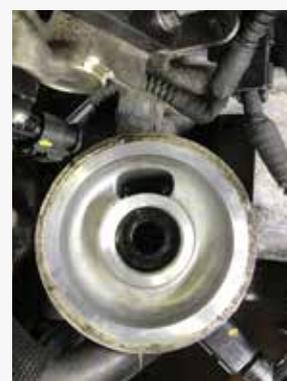
Valve installed correctly

Before installing the new oil filter, ensure the polyamide spigot valve is installed in the housing. If the valve is missing (having 'sprung' out as explained previously), find and clean the original valve, lubricate the 'O' ring-seals, and re-insert it into the housing. Alternatively, you can install a new valve - before installing the new oil filter. (Part No. 06J 115 679 E)

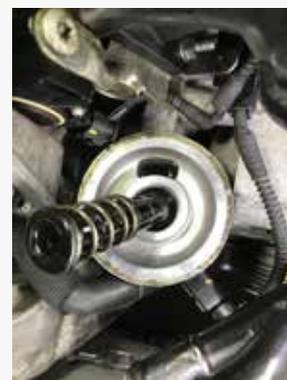
Problems can arise if the valve becomes stuck in the lower position after removing the old oil filter, which is usually indicated by the presence of 'old' oil in the housing. The spring will still be sprung-loaded and the valve can release ('spring' out) at any time. If the new oil filter is installed without the valve, the engine oil flows directly back into the sump after starting the engine. Consequently, the engine cannot reach the sufficient oil pressure - which then illuminates the oil pressure warning lamp.

Valve released

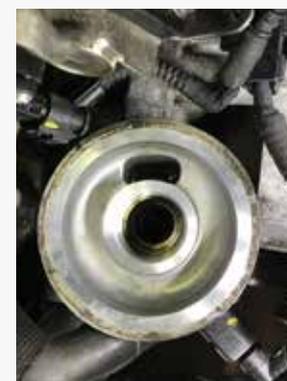
Valve missing
