# 93136

**ISSUE** TURBO-EXHAUST SEALING

## IMPROPER INSTALLATION OF THE GASKET

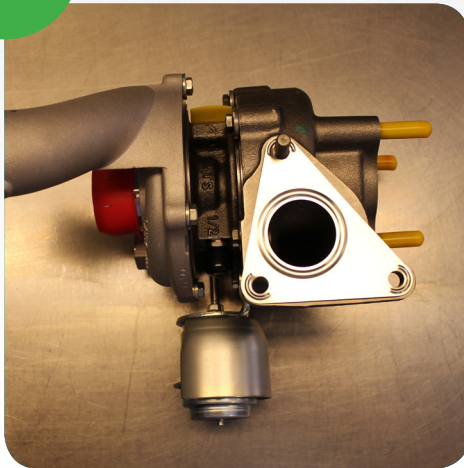
Proper gasket orientation

The gasket must be installed in the correct orientation.

The center hole in the gasket must line up with the turbo outlet/exhaust pipe hole.

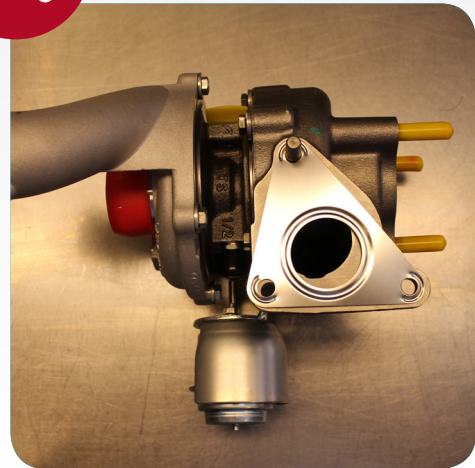
Mounting the gasket in the improper orientation will impair the exhaust flow, instantly affecting proper turbocharger/engine operation (increased back-pressure, turbine wheel cannot operate properly) as well as not sealing the connection properly.

A whistling noise from the turbo-exhaust connection, no proper boost generated by turbo, thus lack of engine power

Improper orientation
