TECHNICAL REPORT

Assembly of cover gaskets
with reference 11105000 and
11105100

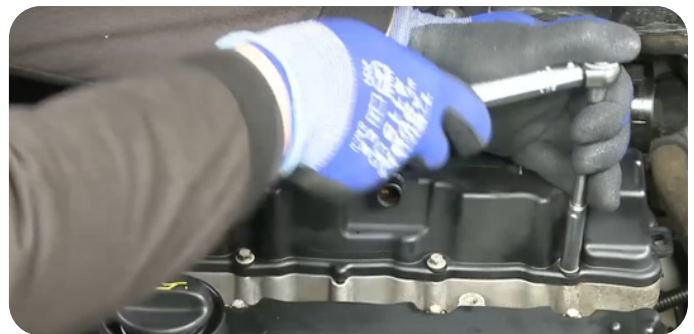
exhaust

intake

8	4	1	5
7	3	2	6

6	2	3	7
5	1	4	8

3) Using the torque wrench, we tighten the torque to 9 Nm in the following order:

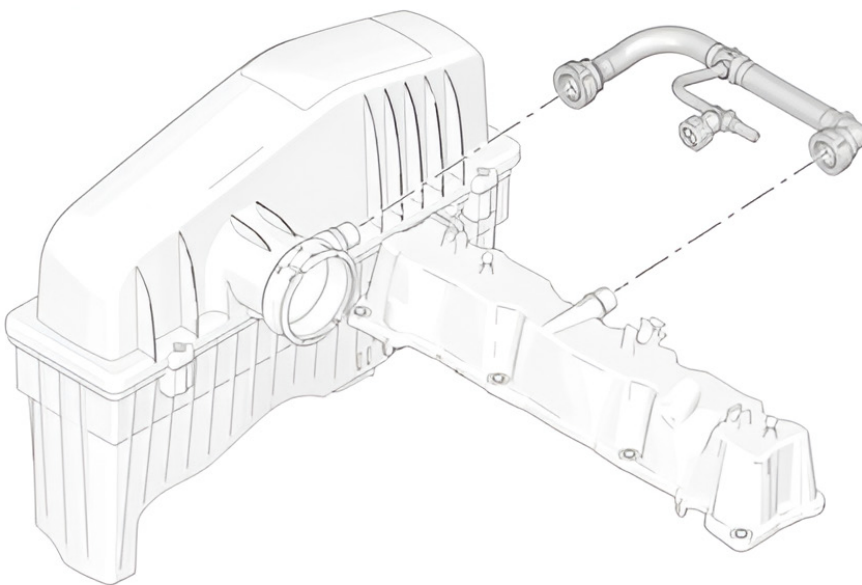
Clogged or damaged PCV valve

If the PCV valve is stuck or not working properly (especially if it sticks closed), internal overpressure builds up in the engine.

This overpressure seeks to “escape” through the weakest points: cylinder head cover gaskets , intake manifold gaskets and eventually other gaskets (crankshaft seal , etc.) causing possible oil leaks and gasket deterioration.

If the PCV valve remains open constantly, it can allow excessive oil-laden gases to enter the intake. This can foul the intake, foul the intake valves, and cause deposits in the combustion chamber.

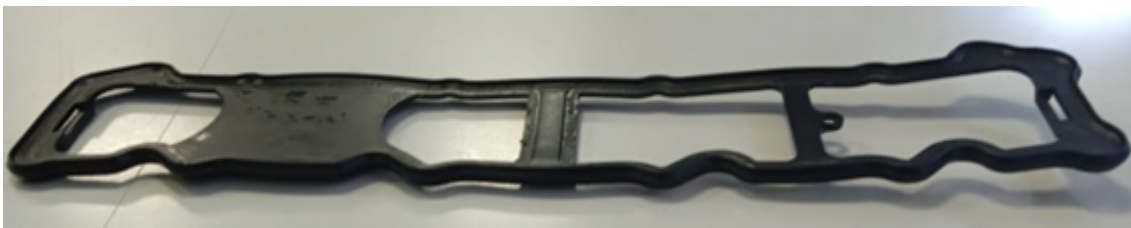
Incorrect tightening

This type of gasket combines **two types of plastic**: a rigid PA plastic, which provides the gasket's rigid structure, and an ACM elastomer, which seals the surface. If the material is overtightened, the rigid material can bend, causing the gasket to deform. This leads to a poor seal in the elastomer and, consequently, oil leaks. The indicated tightening torque is 9 Nm, and the tightening process is performed in a crosswise pattern.
