TECHNICAL REPORT

Turbocharger lubrication
system kit OPK00010

To report to our customers about the new mounting **kit and replacement of charger's lubrication system** in 1.6 HDI engines from PSA group.

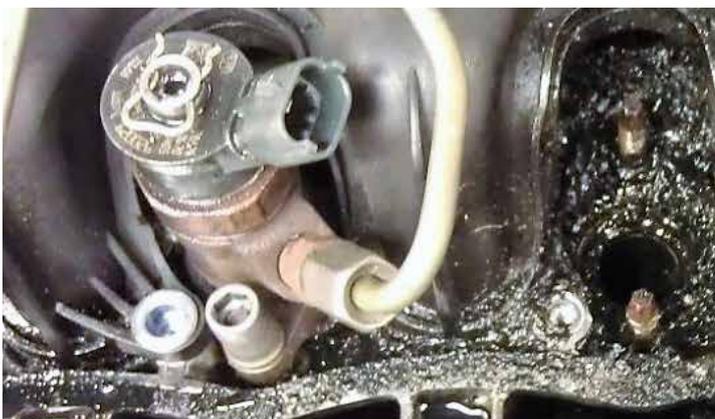
One of the main reasons is **leak of gases through of copper washers** where injectors are seated. This happens since copper washers are in charge of preventing burned gases which are inside cylinders from arriving at the top of the cylinder head where we have oil that lubricates camshafts and lifters.

The cause of gas leaks in this area is not the washer itself, but the **load relaxation generated** by the bolts that hold the injector to the cylinder head. The way to diagnose if this is happening is to listen to see if there are **fring blanks** in that area.

Fire path that is produced for leak of gases in the engine of our vehicle

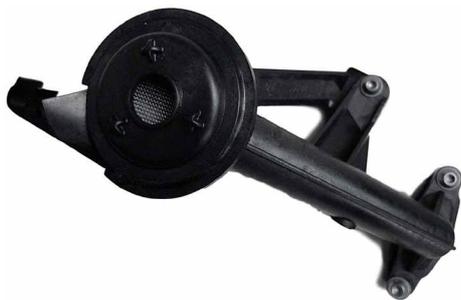
01

01. One of them would be **inside the oil vacuum** pipe in the sump.
02. Other one would be in the **fitting screw** between the turbocharger oil pipe and block.
03. The own **oil filter** itself.

However, with the passage of the kilometers these **filters end up clogging** and reduce the flow to the point of completely blocking the oil flow to the turbo, which generates a **lubrication deficiency** and failure due to wear in components such as the turbo, camshafts, cam, etc.

05. **Oil strainer** (vacuum) must be removed and replaced due to residual carbon/sludge build up.
