124

TECHNICAL REPORT

Ajulock (75000500) thread
locker on flywheel bolts

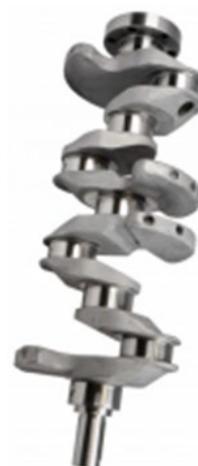
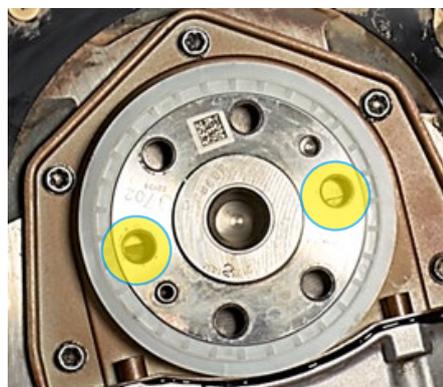
02 THROUGH HOLES CRANKSHAFT

As it not only serves to retain the screws, but also **prevents oil leakage** through the threads themselves, since in some crankshafts the screw threads are not blind, but through, they are in contact with oil from the Carter.

You can see through them the connection of the engine block bedplates.

When the repair involves **reassembling the used flywheel** (for example, replacement of crankshaft seals due to oil leaks) we must take into account the application of **Ajulock thread locker** Ajusa **75000500** (for more information consult [TIP 111](#)) on the flywheel screws.

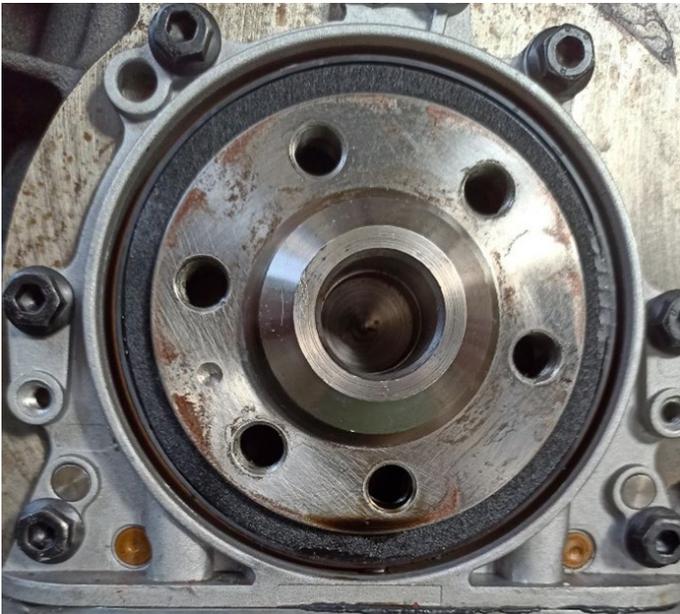
In repairs when disassembling the flywheel it is easy to find oil leakage through the **screw housing** at the bottom of the flywheel (in some engines there is an oil backwater in the lower part of the flywheel).

If any repair involving the disassembly of the flywheel is carried out and these precautions are not taken into account, it can **lead to a loss of oil** in the gearbox area, which is not due to the oil seal.
