TECHNICAL REPORT

Rocker cover gasket for
F8QT Renault engines part
number: 11002800

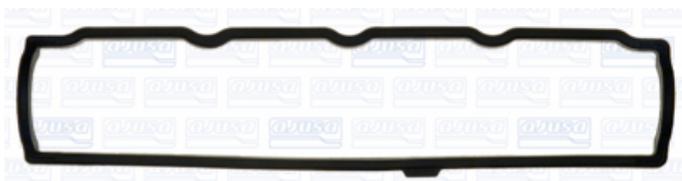
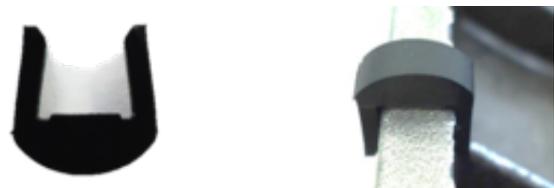
“U” section of the gasket

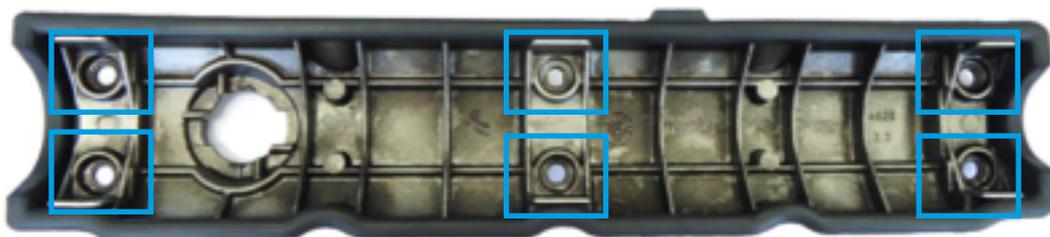
As we can see in the above photo, in the same places where the mechanical stops are, we find the holes for the bolts, which are tightened up to a **specific torque** in order to provide a correct seal against cylinder head.

Because of it, mechanical stops suffer the highest pressure against the cylinder head, and because of they are made from aluminum, a relatively weak material, and also due to the re-tighten procedures and vibrations caused by the engine along the years, mechanical stops wear away and reduce their height.

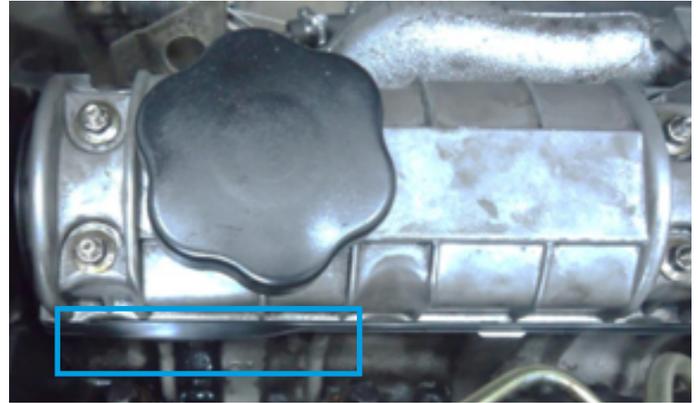
Gasket expelled of its housing

If the wear is not homogeneous in all the mechanical stops (as it usually occurs), we will have at the end different heights and the closing pressure will not be homogeneous any more. When this happens, the rocker cover “expels” the gasket and it occurs where the closing pressure is lower, with the resulting oil leak.

The region with the lowest closing pressure will be located on the opposite side of the mechanical stop with the larger wear (lower height).

In case of opening the rocker cover, **replace the gasket by a new one and check the state** of the mechanical stops.

If the height of the mechanical stops is not homogeneous and the gasket is expelled when installed, it will be necessary to replace the rocker cover by a new one.

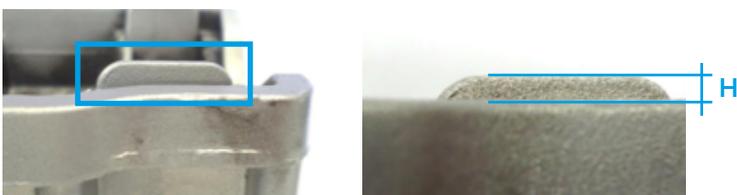
To check if the rocker cover has suffered an irregular wear of its mechanical stops, it is enough **to measure distance** (H) between the surface where the gasket fits and the edge of the mechanical stop, as it is showed below:

In the vehicle we used in our test center, with 183.000 km, the height of the mechanical stops vary within 1.63mm and 1.90 mm, with a result of the gasket expelled from its correct position.

Height of the mechanical stops of a new cover:
H=1.99mm
