# DTE-8008

DKT-8001 / DKT-8003 / DKT-8006  
DKW-8002 / DKW-8003 / DKW-8004

## PROBLEMS WITH POOR BELT TENSION AND A BROKEN SCREW

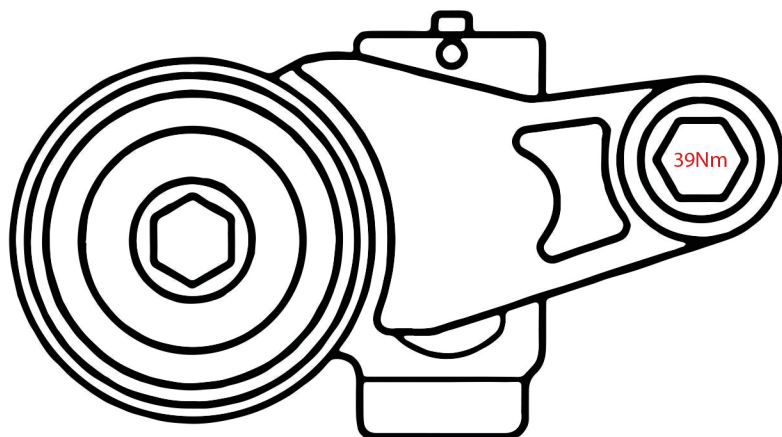
The stress responsible of the screw breakage was caused by the to and fro of the roller. This is due to an insufficient tightening of the screws which failed to press the roller firmly against the engine, the screw then worked in shear rather than in tension. The play that is then created between the roller and the engine causes a belt tension fault, as well as a misalignment thereof.

After breakage, the tensioner pulley rest against the cylinder block, which generally leads to further destruction. The outer ring of the bearing is then often colored as a result of increased temperature due to contact with the belt.

The recommended tightening torque is **39Nm**.

You have to assemble the timing kit as suggested by the manufacturer's installation procedures, as the timing on these types of engines is very specific.
