Service note for VAG accessory unit drives with 1.9 TDI engines without an over-running alternator pulley

Manufacturer: Audi, Seat, Skoda, Volkswagen

Engine: 1.9 TDI

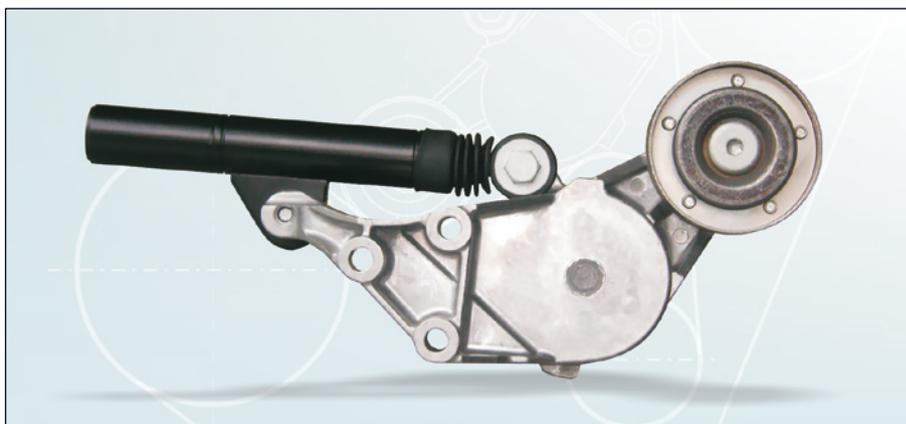
In the worst case, excessive dynamic movement of the poly V-belt can lead to noise build-up, or even damage to the poly V-belt tensioner.

This leads to a failure of the complete assembly drive, which causes the vehicle to break down.

Figure 1: Tensioning unit 533 0081 30 - used in 1.9 TDI engines

In assembly drives with the tensioning unit 533 0081 30 (Figure 1), the rigid belt pulley on the alternator must be replaced with an INA over-running alternator pulley (Figure 2). If an over-running alternator pulley has already been fitted, this must be checked to ensure it is operating correctly.

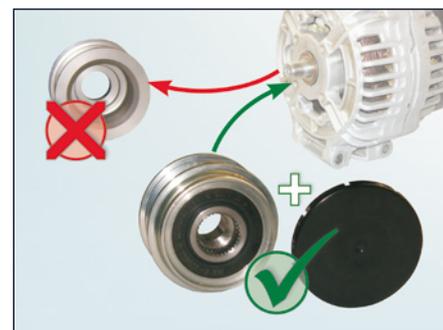
Figure 2: Replacing the over-running alternator pulley

The use of an over-running alternator pulley considerably relieves the pressure on all components within the assembly drive.
