## Noises from front end accessory unit drive area on 1.9 TDI engines

**Engine:** 1.9 TDI

**OE-No.:** 038 903 315 AE

**INA 0044**

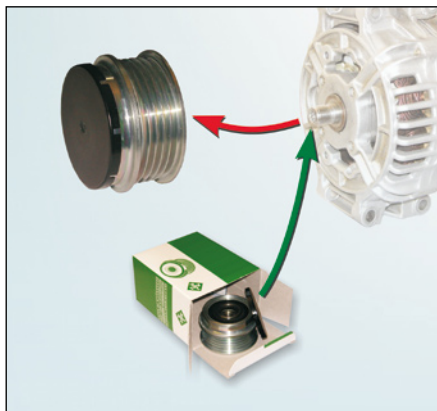
*Image 1: Recommendation: Replace the overrunning alternator pulley*

If the V-ribbed belt is subjected to strong, dynamic movement, this may cause the engine to produce loud noises.

In some cases, the noise continues even after the V-ribbed belt and the tensioner and deflection pulleys have been replaced.

The recommended repair is to replace the overrunning alternator pulley.

This considerably relieves the pressure on the assembly drive by reducing both the tension peaks on the belt and the vibration behaviour.

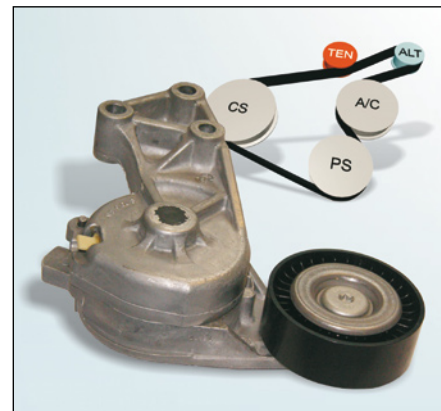
*Image 2: Tensioner lever 534 0132 30 installed in 1.9 TDI engines with belt path*
