# SERVICE INFO

## Note on installing tensioning pulley 531 0317 10 with base plate fixing

**Part no.:** 531 0317 10

**INA 0076**

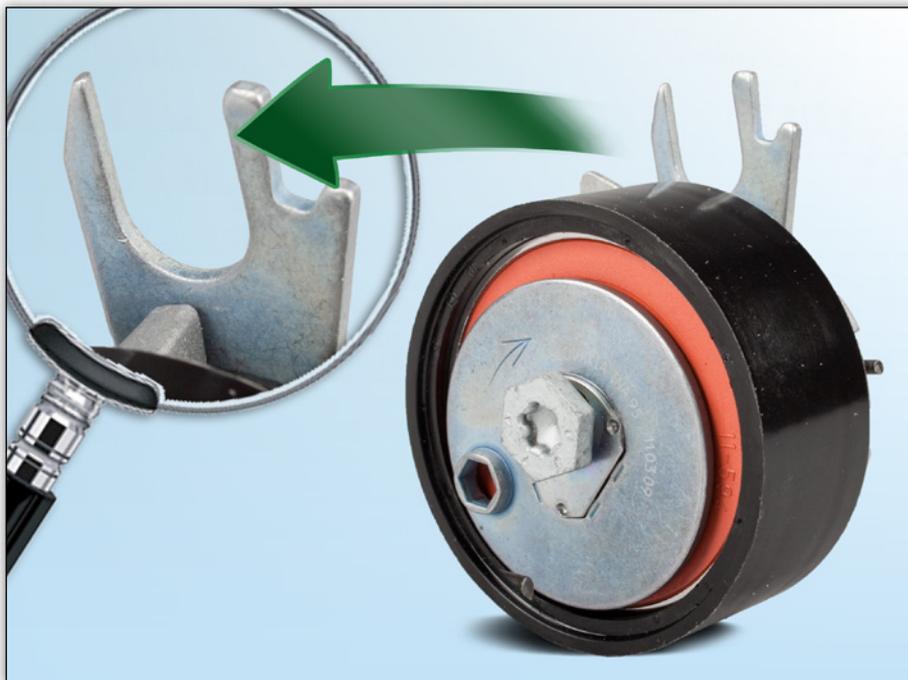
**Image 1:** 531 0317 10 – Tensioning pulley with base plate fixing

If the base plate is fitted incorrectly, this could cause the tensioning pulley to malfunction.

When installing tensioning pulley 531 0317 10, always ensure that the base plate is positioned correctly. The base plate must be correctly positioned in the designated retainer on the engine block.
