Volkswagen Passat Clutch Replacement

A SMART conversion

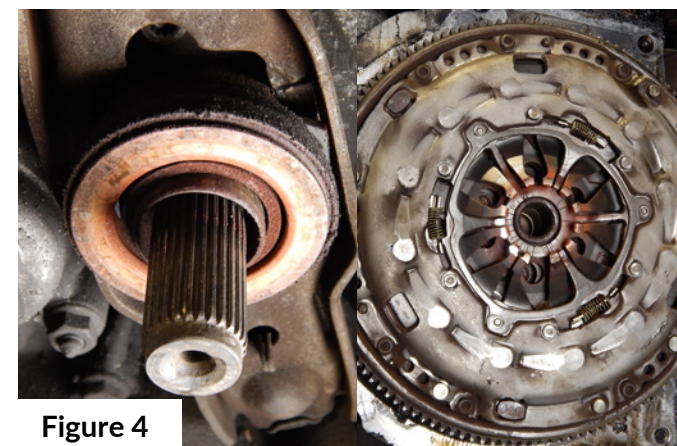
Figure 4

The clutch pressure plate, friction disc and flywheel were removed and inspected. Upon inspection of the release bearing, it was apparent that it had become worn and sticky

in operation; however, the root cause of the noise and high frequency vibration was the flywheel. Although there were no signs of scoring/cracks or 'blueing' on the friction contact surface, it was obvious that the flywheel had excess 'free play' when tested, as well as an internal material failure. (Fig 4) The conclusion was that the complete clutch kit was in need of replacement.

To carry out this work, Blue Print SMARTFIT Conversion clutch kit ADV183059 was chosen. This includes a complete four-piece dual mass flywheel conversion kit with torsion-damper friction disc, pressure plate, solid flywheel, grease, release bearing and all necessary bolts, and a SMARTFIT installation sticker.

The crankshaft was inspected and cleaned along with the rear main oil seal, before fitting the new solid flywheel. The new bolts were then tightened to manufacturer specification.
