Technical Bulletin

Mitsubishi Pajero, Shogun, Shogun Sport, Shogun Pinin, L200, L300, Challenger, Strada, Delica - Mainshaft spigot Bearing Failure

Applicable References: ADC43399, ADC43398, ADC43397

Date Issued: 05/2006

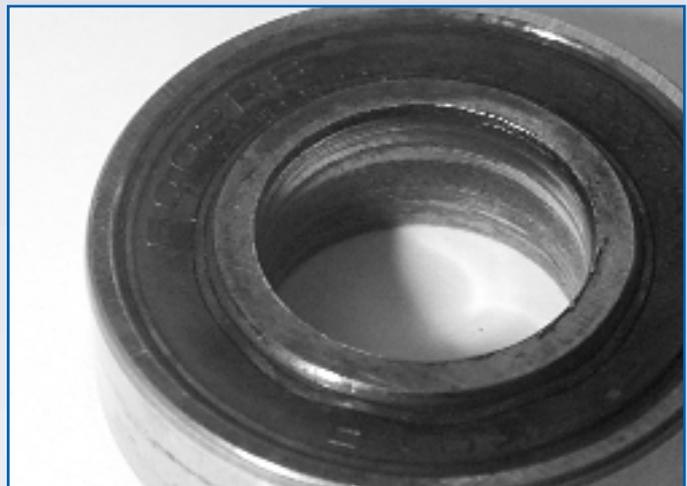
A seized flywheel bearing may cause the transmission spigot bearing to spin and wear inside the bearing race or the outer bearing casing to spin and wear inside the flywheel.

Flywheel bearing failure will often cause transmission spigot bearing failure and misalignment damage to the clutch assembly.

Picture showing wear between the transmission spigot and the inside of the bearing inner race, due to the spigot bearing seizure.

The bearing is pressed into the flywheel with an interference fit. Care should be taken when installing this bearing. Ensure the race is not 'pinched' when fitted.

It is advisable to replace the spigot bearing as a precautionary measure whenever the clutch assembly is removed.
