Technical Bulletin

NISSAN NAVARA D40/PATHFINDER R51 – Four Wheel Drive Malfunction

Applicable References: ADN11489, ADN11490, ADN11491, ADN17225, ADN17226, ADN17235

Applications: Nissan Navara D40 & Pathfinder R51 up to build date 15/09/2009

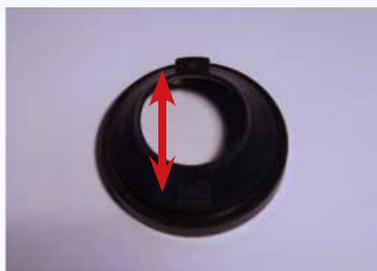
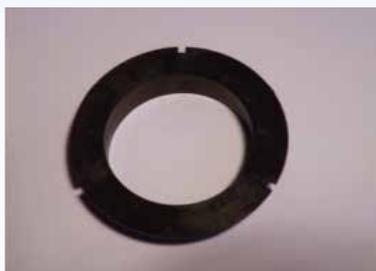
The modified dust cover has two drain holes and should be installed with these holes positioned vertically (12 and 6 o'clock), not horizontally (3 and 9 o'clock).

It is recommended that you drain the transfer box of oil, replace the rear prop-shaft oil seal (**ADN17235**) and fit a new modified dust cover and spacer (**ADN17226 + ADN17225**). The spacer should be installed inside the dust cover before fitting.

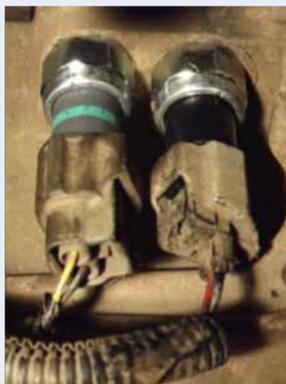
4wd low switch/
Automatic transmission
park switch

The other two switches are positioned together and further forward on the underside of the transfer box. These are:

- **4wd Low Switch** (Grey with green stripe) - **ADN11489**.
- **Automatic Transmission Park (ATP) Switch** (Black) - **ADN11490**.

Although the diagnosis may only show one switch to be faulty, it is recommended that all three switches are replaced because of the increased risk of premature failure due to water ingress into the transfer box.

We recommend you replace the switches one at a time to prevent the risk of incorrect positioning/fitment.

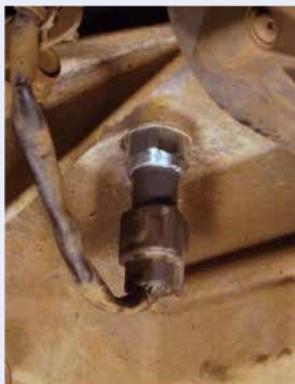
4wd shift switch

The three switches are located on the underside of the transfer box. The switch located towards the rear of the transfer box is:

- **4wd Shift Switch** (Grey) - **ADN11491**.

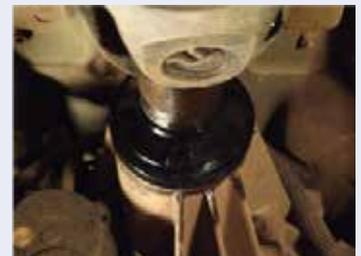
Modified dust cover fitted
in correct position
