Blue Print ADM57652

Ford Ranger 2.5 and 3.0 TDCi, Mazda BT50 2.5 and 3.0 DT

Timing belt tensioner

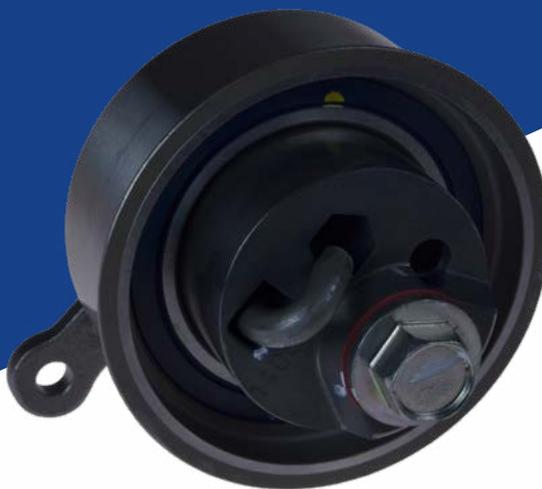
Soft, weak or inadequate belt tension following the replacement of tensioner pulley.

When fitting a new tensioner, if the tensioner pulley has no resistance, bleed the air from the pressure chamber using the following procedure before fitting the timing belt.

Bleed the air from the tensioner pressure chamber using the following procedure before fitting the new timing belt.

- Assemble the auto tensioner onto the engine.
- Turn the tensioner with a force of 39Nm or less using an Allen key, then turn it back slowly.
- Repeat this procedure several times.
- Verify that the piston rod has resistance when it is in the projected position.
- If there is no resistance then repeat.

Once satisfied that the tensioner is working correctly, proceed with fitting the new timing belt according to vehicle manufacturer's fitting instructions.
