Blue Print ADM58089, ADM58096

To fit:
Ford, Mazda and Volvo various models

Control Arm Bush

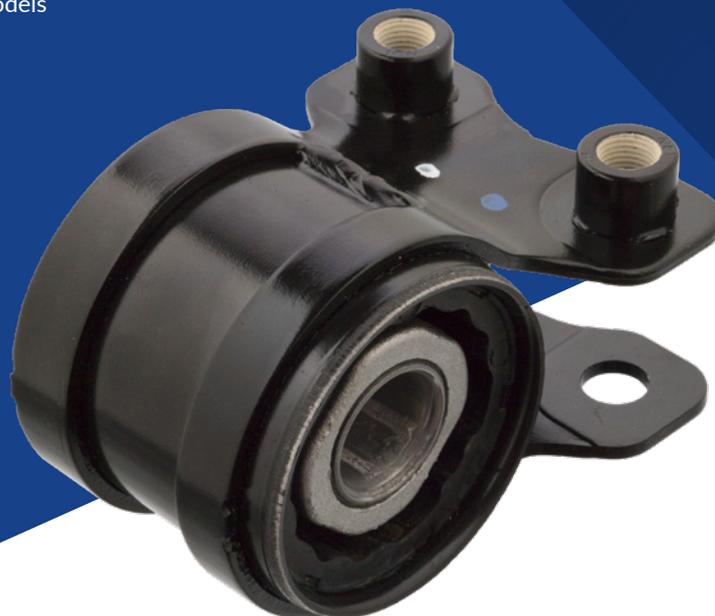
Uneven tyre wear and misaligned front suspension.

Worn lower suspension control arm control bush.

Blue Print provides an economical repair solution; the control arm bush can be replaced instead of replacing the complete suspension control arm. When replacing this bush it is important that the alignment of the original control arm bush be followed. If the bush is not aligned correctly on the shaft of the suspension arm, there is a risk of premature failure and a shortened lifetime of the component.

There is a special tool available from the vehicle manufacturer to assist in the replacement of the control arm bush.

By using this tool, it can be ensured that the installation position and press-fit depth of the bush will be correct.
