# Blue Print ADN17201

to fit:

Nissan Almera, Almera Tino, Expert, Micra, Note, Primera, Sunny, Wingroad 1.0, 1.2, 1.4, 1.5, 1.6, 1.8 Petrol engines

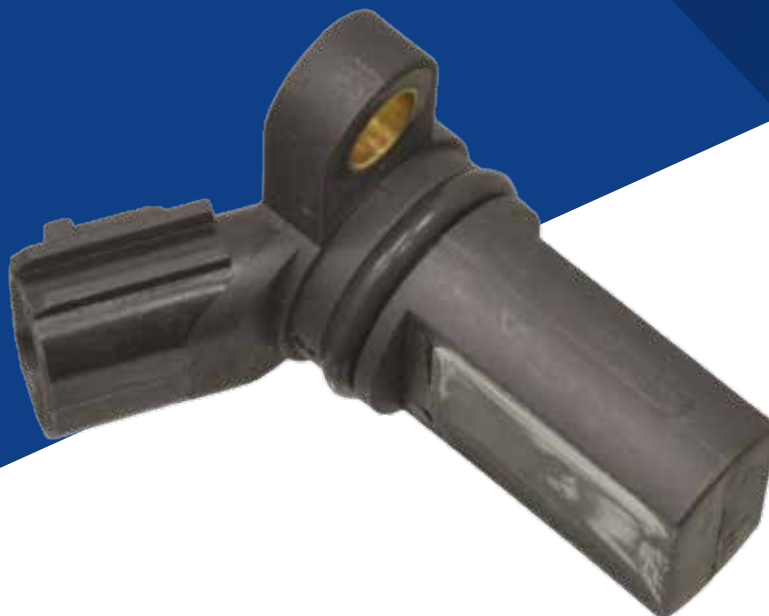
Incorrect camshaft and crankshaft synchronization, giving symptoms of poor acceleration and erratic engine rpm.

The engine control unit may also have a number of fault codes stored, for example P0011 Camshaft 'A' timing (Bank 1), P0335 Crankshaft position sensor and P0340 Camshaft position sensor. This could be diagnosed as a simple sensor replacement.

When diagnosing these faults, these engines are prone to camshaft/crankshaft synchronization issues, which can give the above symptoms, this is frequently due to a worn timing chain.

Check the position and alignment of the engine timing and replace all worn components as necessary, before condemning the crankshaft or camshaft sensors.
