Blue Print ADA107106, ADC47118, ADG07149, ADG07150, ADM57101, ADM57110, ADN171123, ADBP710021

ABS Ring

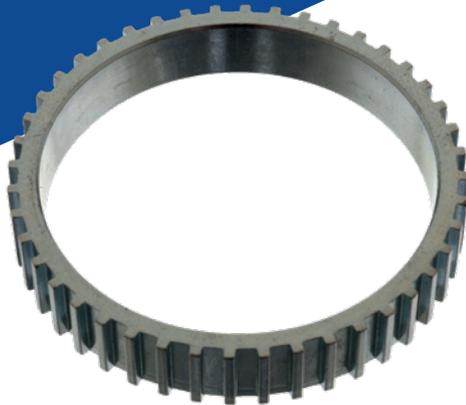
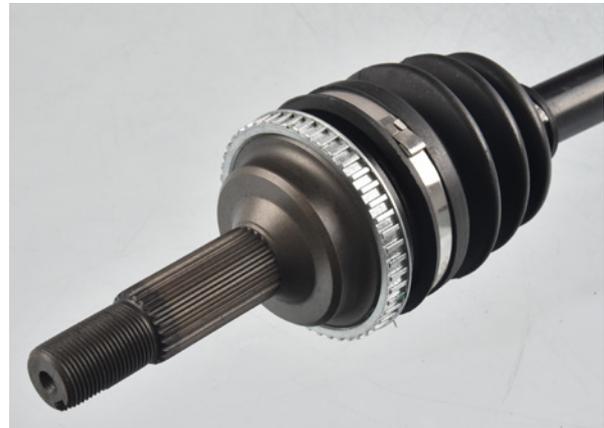
The anti-lock braking system (ABS) warning lamp is illuminated, wheel-speed sensor fault codes are present in the control units, there is a 'grinding' noise whilst driving, the brake pedal is 'pulsating' under light braking, and the cruise control is not working correctly.

There is excessive corrosion build-up on the driveshaft joint where the ABS ring is located, causing the ring to split. Alternatively, the ABS ring has become corroded or damaged. It is therefore giving an incorrect wheel speed reading.

Remove the affected driveshaft from the vehicle - as well as the ABS speed sensor if required.
Remove the broken or corroded ABS ring from the driveshaft joint by 'prizing' it off with a chisel or old screwdriver, taking care not to damage the surface of the driveshaft joint.
Clean the joint using steel wool or emery cloth to remove all corrosion from the mating surface.
Heat the new ABS ring to allow the metal to expand, then insert the new ABS ring onto the joint, ensuring it is seated correctly. Allow it to cool for a permanent fixing.
Inspect the ABS sensor for damage and replace as necessary.
Refit the repaired driveshaft to the vehicle and reset any fault codes caused by the faulty ABS ring with suitable diagnostic equipment.
