Blue Print

ADBP210027, ADBP990012, ADV182110

Various Volkswagen, Audi, Seat and Skoda models fitted with the 1.6 and 2.0-litre TDi engine.

Oil Filter, Oil Filter Cap, Oil Filter Housing

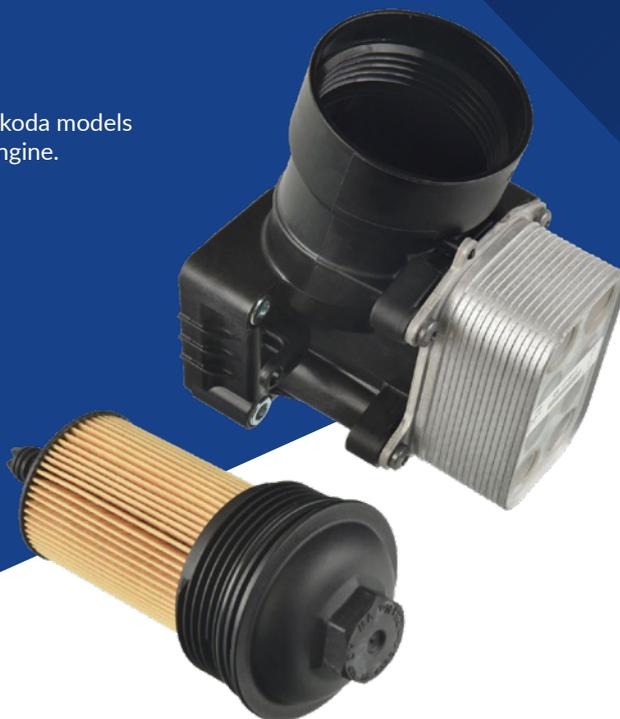
Oil leaking from the engine oil filter housing.

The oil filter cap and housing, which is made from a hard and durable thermoplastic, becomes weak or damaged following repeated unscrewing and tightening. This is most likely to occur if the cap is not correctly aligned, or is over tightened during the filter element replacement.

When replacing oil filter ADV182110, inspect the cap and housing for any distortion or damage to the threads. If there is any damage found replace the cap with ADBP990012 or the complete housing ADBP210027, where necessary.

When replacing and fitting the new filter element, coat the new "O" ring seals (fitted to the cap) with clean engine oil. Insert the cap and filter assembly into the housing and, in a clockwise direction, screw in; tightening to 25 Nm as illustrated on the cap. Fill the engine to the correct level with fresh oil. Following this start the engine and check for any oil leaks.
