PROTIPS

Blue Print ADBP720076

To fit:
Honda Civic (FK3), CRV (RE6), HRV (RU8)

Manifold Pressure Sensor

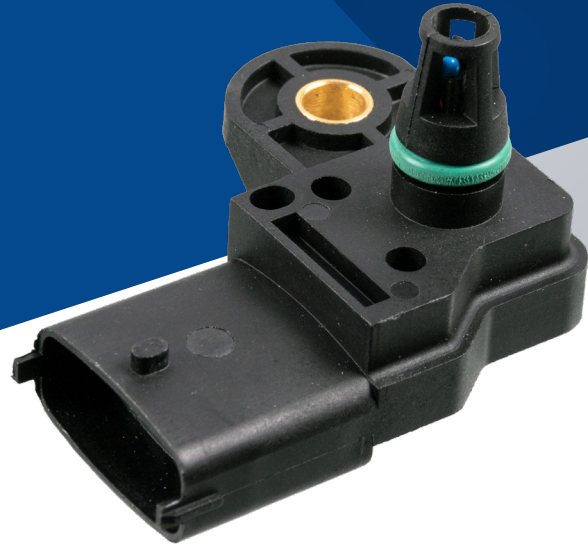
Engine warning lamp illuminated, reduced engine power and the vehicle going into limp home mode.

Moisture in the exhaust gas recirculation system can adversely affect the MAP sensor's temperature-sensing element. This can alter the sensor's voltage, current and resistance characteristics, resulting in an incorrect reading.

Check the data from the sensor with a suitable diagnostic tool, then replace the faulty MAP sensor and clear any fault codes.
