Blue Print ADBP740009

Lexus CT200h ZWA1, Toyota Auris Hybrid ZWE150, ZWE186,
Prius ZVW30, ZVW35, Prius + ZVW40.

EGR Valve

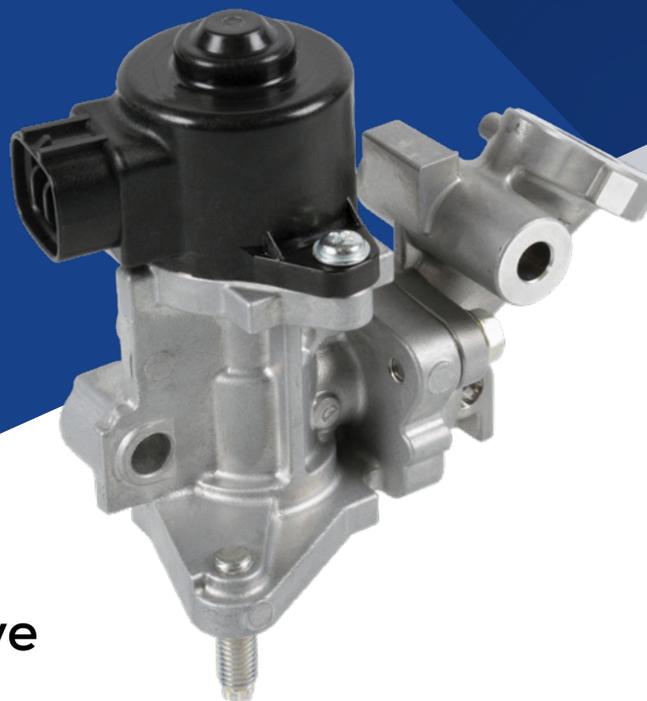
Vehicle vibration due to rough idle and/or a tapping noise from the transaxle.

Engine warning light is on and diagnostic trouble code P0401: "Exhaust gas recirculation flow insufficient detected" is logged in the engine control unit (ECU).

The wiring harness multi-plug, connected to the exhaust gas recirculation (EGR) valve, is under tension as the engine moves. This causes an intermittent open circuit and the incorrect operation of the EGR valve. As a result, a build-up of carbon deposits occurs in the valve assembly - causing the valve to fail and the engine rpm to fluctuate.

Remove the insulation tape from the wiring harness. Then, re-route the EGR valve wiring harness - making sure to leave sufficient slack to allow for engine movement. Re-apply the adhesive tape to the base of the wiring harness and replace the faulty EGR valve. To complete this repair, the engine control unit will require re-programming with upgraded software from the vehicle manufacturer.
