Blue Print ADC47347, ADC47353

Mitsubishi Montero, Pajero and Shogun models fitted with 4M41 diesel engine

Timing Chain Kit

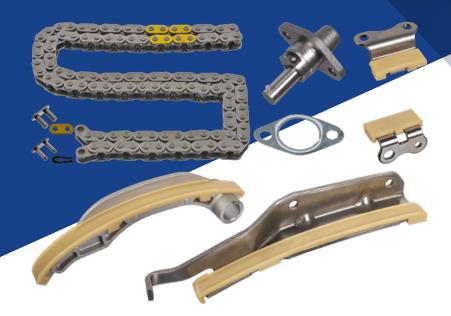
A rattling noise coming from the engine timing chain area or a broken timing chain.

The timing chain tensioner's wear is accelerated during operation. This is caused by the high carbon deposits that build up in the oil, due to exhaust emission control measures implemented on this engine.

It is possible the tensioner will stick and no longer function properly. This in turn will result in an un-tensioned timing chain, causing a rattling noise or the chain to break.

Remove the timing chain tensioner and inspect it for excess wear, damage and over extension of the plunger. This is checked by looking at the scratch marks between the contact surface of the cam and the plunger rack. If the plunger has extended beyond the normal operating range, there will be marks from the seventh position onwards. The cam can also sustain damage to the teeth, therefore restricting the operation of the cam.

Remove the rocker cover assembly. Using a flat blade screwdriver, raise the timing chain off the timing chain guide surface and inspect the condition of the chain running surface. A pitted wear surface is caused by a flapping untensioned timing chain.

Once the cause has been confirmed, replace the timing chain kit according the workshop manual, including changing the engine oil and filter.
