# Blue Print ADG070136

Hyundai i10 (PA) 2008 > 2017, Kia Picanto (TA) 2011 > 2017

## Oxygen sensor

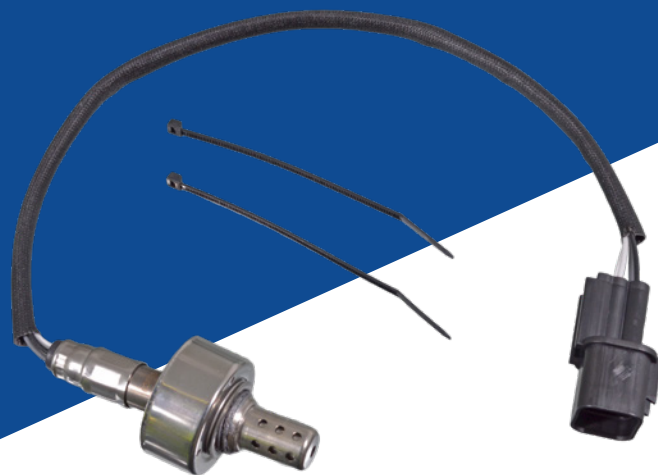
The engine is running unevenly, fuel consumption has increased and the 'check engine' warning lamp is illuminated. Fault code P0141 - O2 sensor heater circuit (bank 1, sensor 2) malfunction is stored in the engine control unit (ECU). The fault re-appears after a new oxygen sensor has been fitted.

The wiring harness that is connected from the oxygen sensor to the ECU has a high electrical resistance value, causing the issues listed above.

Before replacing the oxygen sensor, a test of the wiring harness that connects the oxygen sensor to the ECU should be completed. This is due to an intermittent out-of-tolerance electrical resistance reading, causing the P0141 fault code. If the fault is detected in the wiring harness, either a replacement harness will be required, or a repair on the existing harness will have to be carried out.

When the necessary work has been completed, clear the fault code from the ECU using a suitable diagnostic tester and perform a road test.
