To fit:
Various Volkswagen, Audi, SEAT
and Škoda models.

Oil Filter

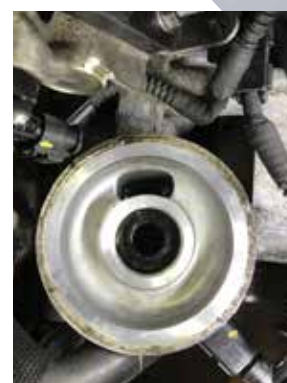
Valve installed correctly

Before installing the new oil filter, ensure the polyamide spigot valve is installed in the housing. If the valve is missing (having 'sprung' out as explained previously), find and clean the original valve, lubricate the 'O' ring-seals, and re-insert it into the housing. Alternatively, you can install a new valve - before installing the new oil filter. (Part No. 06J 115 679 E)

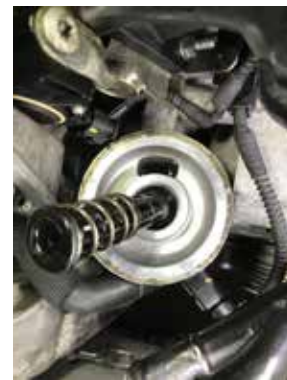
Problems can arise if the valve becomes stuck in the lower position after removing the old oil filter, which is usually indicated by the presence of 'old' oil in the housing. The spring will still be sprung-loaded and the valve can release ('spring' out) at any time. If the new oil filter is installed without the valve, the engine oil flows directly back into the sump after starting the engine. Consequently, the engine cannot reach the sufficient oil pressure - which then illuminates the oil pressure warning lamp.

Valve released

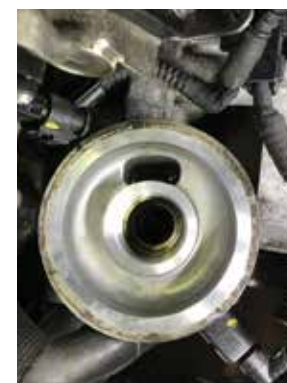
Valve missing
