ROCKER ARMS AND SHAFTS FOR THE FORD DURATORQ ENGINE

ROCKER REPLACEMENT

Ford Duratorq

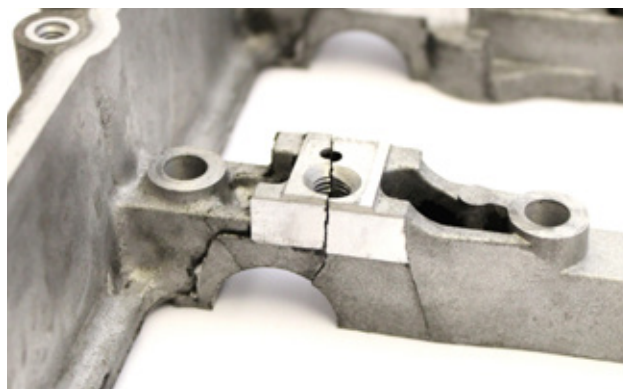
Timing failure (resulting in Cylinder Head replacement) because of Cam carrier damage or one of the symptoms stated above, could have been caused by a bent Rocker Shaft and worn Rockers.

Damage to the Cam carrier

- Examine the Rocker Shafts and replace if bent or worn.
- Examine the Rocker Arms for wear on the bearing faces and at the Hydraulic Lifter tip. Always replace Rocker Arms as a set if any are worn or damaged.
