## HN5372

## SUMP DILUTION

VAG 1.9TDI PD engine

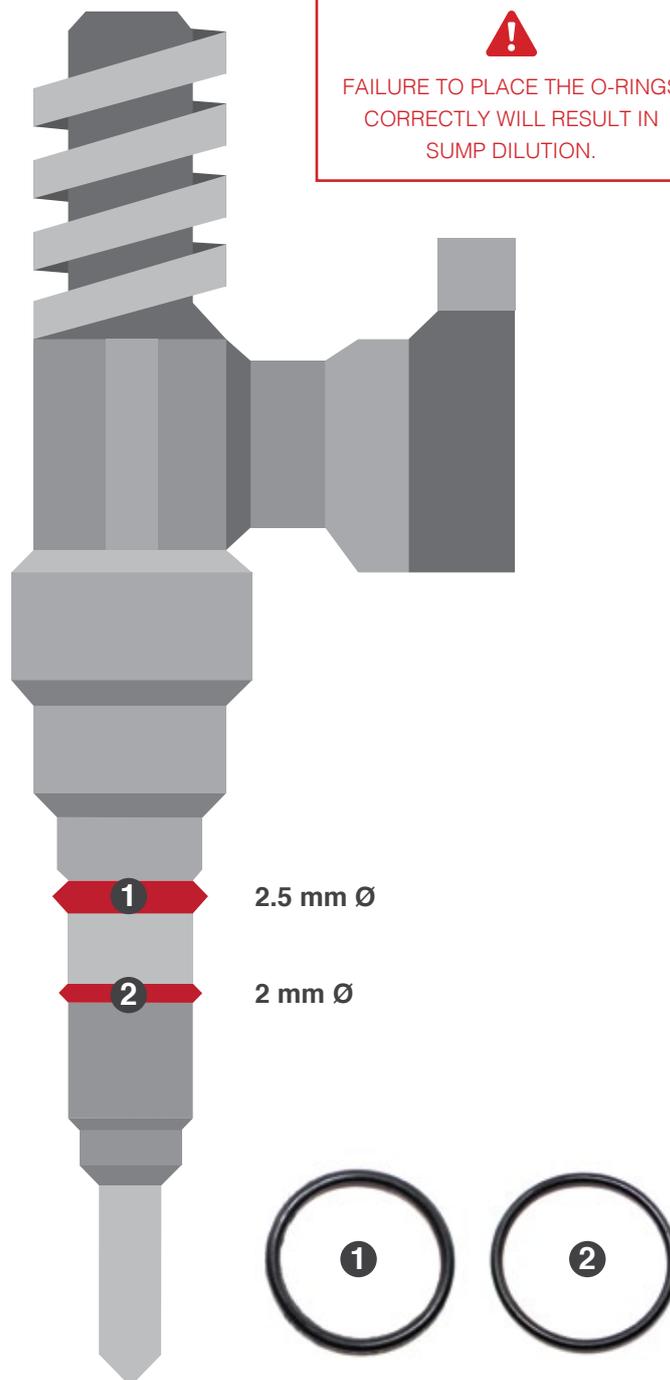
O-ring installation:

Incorrect installation of the o-rings from the HN5372 BGA Cylinder Head service kit will result in diesel fuel entering the engine's lubrication system, causing engine damage.

FAILURE TO PLACE THE O-RINGS CORRECTLY WILL RESULT IN SUMP DILUTION.

The Injector rings must be installed as per the diagram.

**!** HN5372 CONTAINS TWO DIFFERENT O-RING SIZE SETS. THEY NEED TO BE INSTALLED IN DIFFERENT PLACES.
