THE VAUXHALL Y17DT ENGINE SUFFERS WEAR TO THE OIL PUMP AND TIMING PULLEY.

## OIL PUMP MOVEMENT ISSUE

Opel/Vauxhall Y17DT; Y17DTL; Z17DTH; Z17DTL; Z17DTJ Engines.

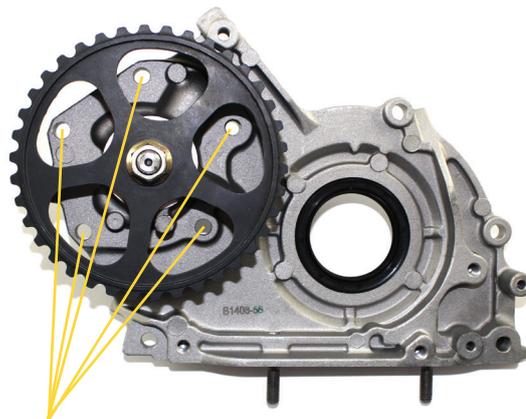
Diagram 1

The bolt holes are accessible; Pulley removal is not necessary.

- During Timing Belt replacement, thoroughly examine the Oil Pump's rotor shaft, rotor drive contact face and behind the drive pulley for wear. If evident, replace all
- Never replace an Oil Pump without a new Pulley and locking nut
- Do not tighten beyond 25nm or 18.5 ft-lbf
- Removing the Pulley is not required during installation of the BGA Pump because it could damage the rotor seal (*Diagram 1*)
- Apply adhesive sealing compound as shown by the dotted area in *Diagram 2*

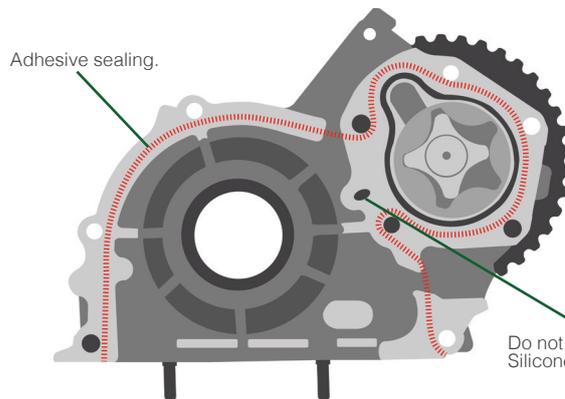
Diagram 2

Do not apply Silicone in this area.

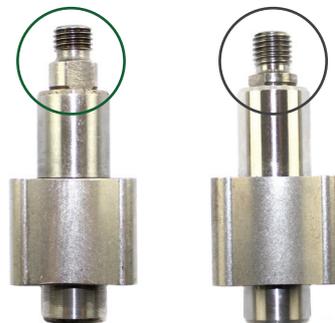
Diagram 3

Movement between the Shaft and Pulley's contact faces due to insufficient tightening of the securing nut can affect the Oil Pump longevity. The nut will become loose and not re-tighten resulting in timing or lubrication failure. The OE equivalent has  $3 > 5^\circ$  of movement.

The rotor and Drive Pulley contact areas have been increased by 72% which reduces the movement tolerance to  $0.5 > 1^\circ$ . The Pulley has been secured and correctly torqued negating the need for removal during installation. (*Diagram 3*)
