# **febi 38362, 46140**

BMW E84, E89, F10, F25, F30 fitted with N20 & N26 Engines

## Timing Chain Kit, Chain Kit for oil pump

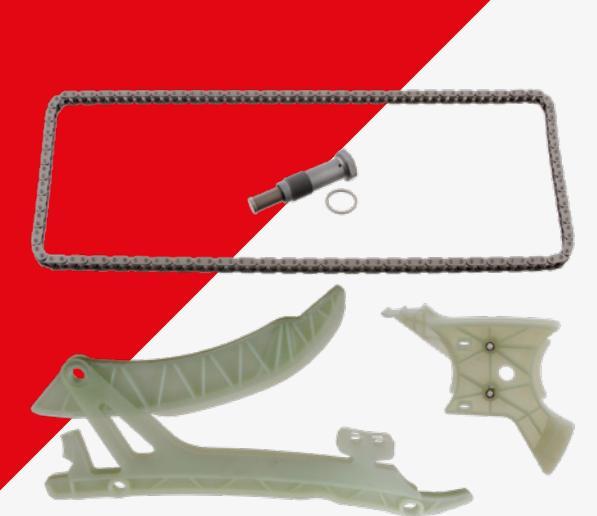
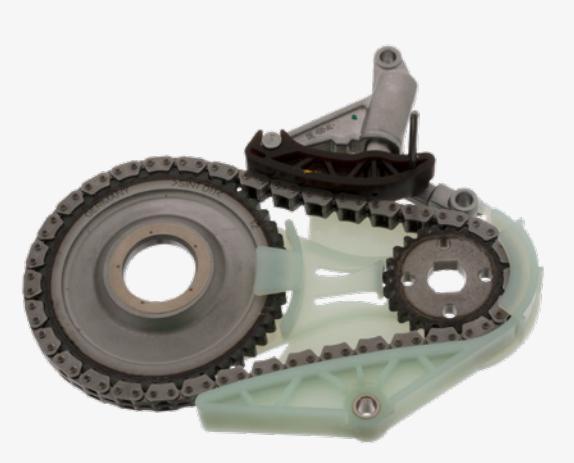
High pitch whining noise from the lower engine area near the engine oil pump, which increases in frequency as the engine RPM advances.

Engine oil pump chain drive sprockets worn.

Remove and inspect timing chain and oil pump drive sprockets, guides, tensioners & chains for wear. Replace the worn engine oil pump chain drive module (46140) and timing chain kit (38362) following the vehicle manufacturers procedures and replace engine oil & filter.
