🖻 febi 39730, 39547

Vauxhall, Opel, Saab, Fiat, Alfa Romeo various models. 1.9 Diesel Engines

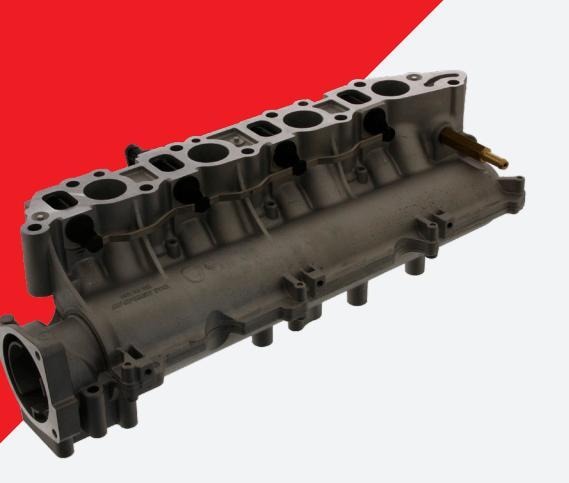
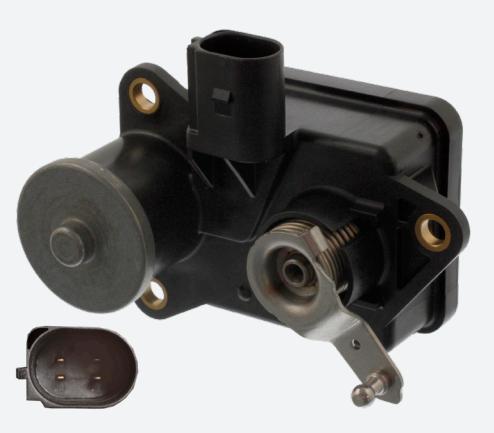
Poor engine performance, vehicle in limp home mode, swirl actuator malfunction and the engine management lamp illuminated.

This engine was designed to improve the air/fuel mixture combustion. This was achieved by adapting the air entering the engine, through two separate intake channels in the inlet manifold. Each cylinder has an extra intake channel which in each case is equipped with an adjustable swirl flap, this is actuated through a lever arrangement controlled by the electric drive module. Through the position of the swirl flaps, the swirling of the intake air in the cylinder can be adapted to the specific load conditions of the engine.

In time these inlet manifold swirl flaps often become worn or start to stick. This is due to a build-up of carbon deposits caused by poor combustion, frequent short journeys, and faulty crankcase ventilation.

Replace the faulty inlet manifold (febi 39730). It is also advisable to replace the control valve (febi 39547), because this is an intelligent self-learning component. The old unit would have adapted itself to the worn inlet manifold and cannot relearn.
