VKBA 7455

Technical Bulletin - May 2009

SUZUKI Grand Vitarra 1.6, 2.0, 2.5 - ABS fitted

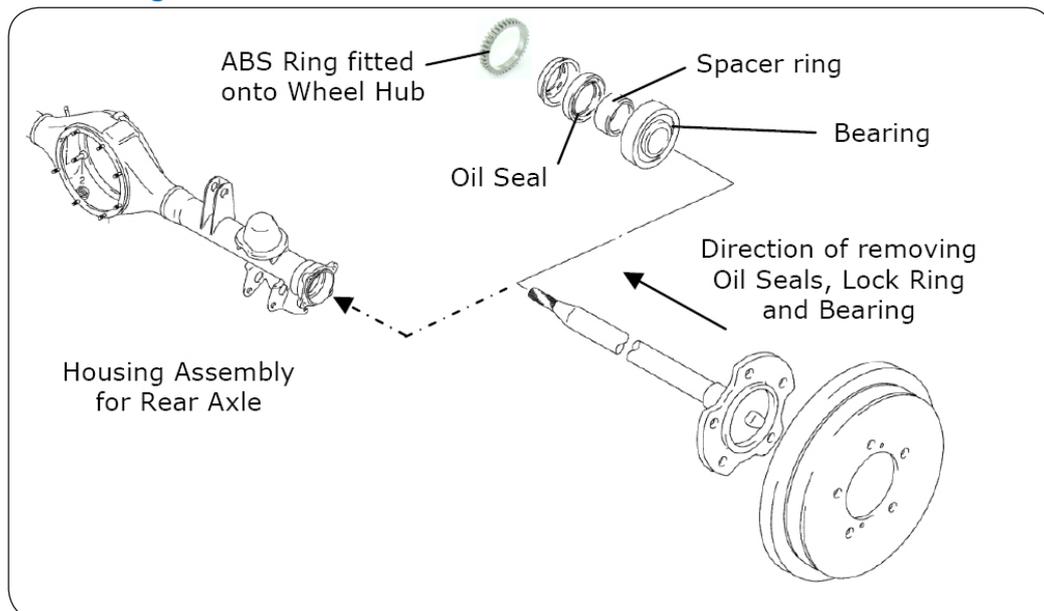
Axle design - ABS fitted

The ABS ring can be destroyed during bearing change process in particular when dismantling the axle and to gain access to components.

Oil Seals

Spacer Ring

Bearing

ABS Ring

As result SKF offers choice of kit to suit mechanics requirement.
VKBA 7455 kit - includes ABS ring - use if broken / damaged
VKBA 3924 kit - no ABS ring – choice if not broken /can be reused
