SKF Technical Bulletin

VKBA 3418 – Fitting Instructions

VOLVO 850, 850 Estate, C70 I Convertible/Coupe, S70, V70 I

Fitting instructions: Caution when mounting the Wheel bearing kit VKBA 3418

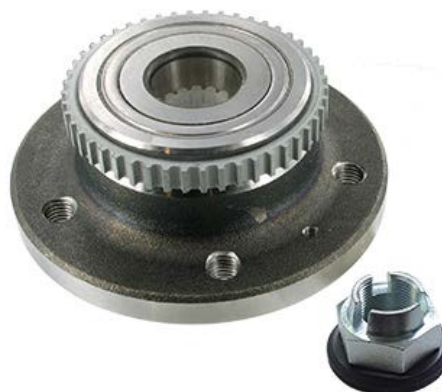
VKBA 3418

Likely causes

- Wrong tools used
- Wrong mounting
- Wrong applied force

Consequences

- Bearing inner rings could be separated, despite the plastic secure ring
- Bearing outer rings can move out of the bearing due to the press fit, when the shaft gets pushed through the inner ring
- The balls and raceways will get damaged as the mounting force is transmitted through the balls and raceways
- Premature bearing failure/damage (due to water ingress....)

Solution

- Use correct tools for a proper mounting
- Apply correct force
