# SKF Technical Bulletin

## VKBA 3425 – Fitting Instructions

VOLVO S90 I, V90 I Estate, 960 II

Fitting instructions: Caution when mounting the Wheel bearing kit VKBA 3425

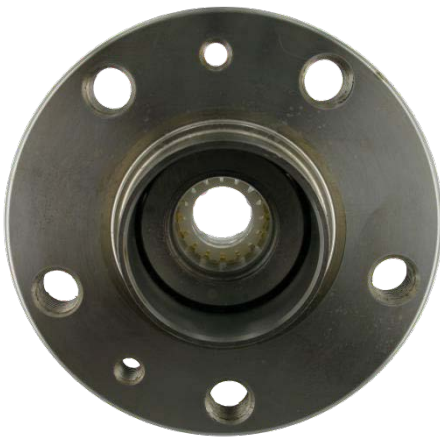
SKF use safe packaging solutions to protect the wheel bearing from damage during transport or mounting. VKBA 3425 is delivered with a plastic joining sleeve, to keep the inner rings together, until the bearing is mounted on the car.

Bearing with plastic  
Joining sleeve

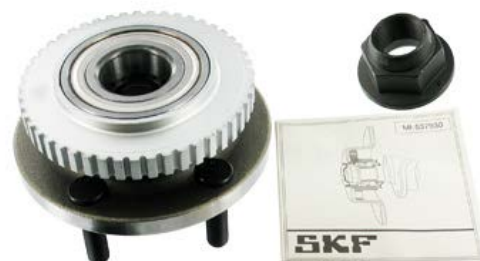
## VKBA 3425

- Wrong tools used
- Wrong mounting
- Wrong applied force

- Bearing inner rings could be separated, despite the plastic secure ring
- Bearing outer rings can move out of the bearing due to the press fit, when the shaft gets pushed through the inner ring
- The balls and raceways will get damaged as the mounting force is transmitted through the balls and raceways
- Premature bearing failure/damage (due to water ingress....)

- Use correct tools for a proper mounting
- Apply correct force
