Light Commercial Vehicles (LCV's) Starters

Premature failure of replacement starter for LCV's

This bulletin outlines common reasons of premature failure for DENSO starters DSN3013 and DSN3014 fitted as replacement starters in Fiat Ducato, Citroen Jumper and Peugeot Boxer. The root cause for the potential failure has been identified and instructions to prevent recurrences are provided below.

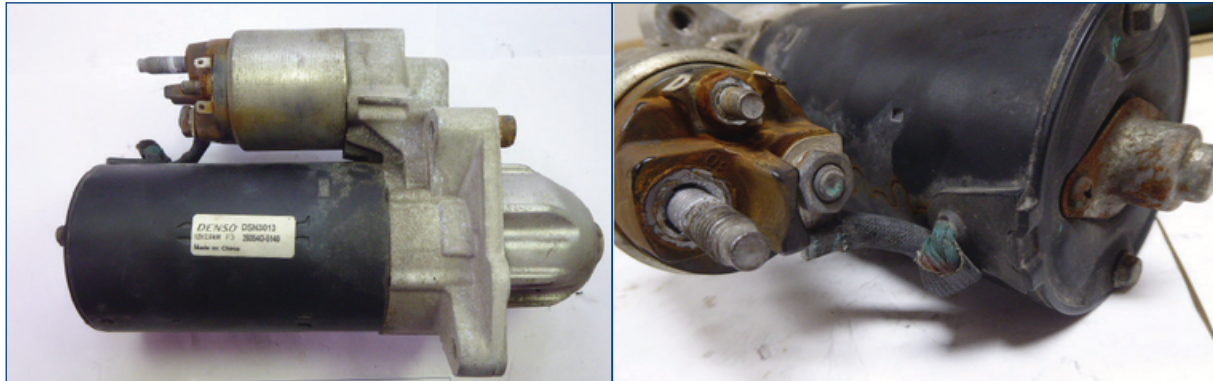
Investigation has shown that replacement starters fail prematurely after installation due to (extreme) water ingress, causing severe corrosion of the starter inner parts and housing.

Starter is corroded on the outside

Make sure the complete lower engine cover is properly installed or avoid driving through deeply flooded roads to prevent splash water entering the replacement starter motor.

! Be careful when using a high-pressure cleaner. Do not point directly to the starter motor when cleaning the engine and engine bay.

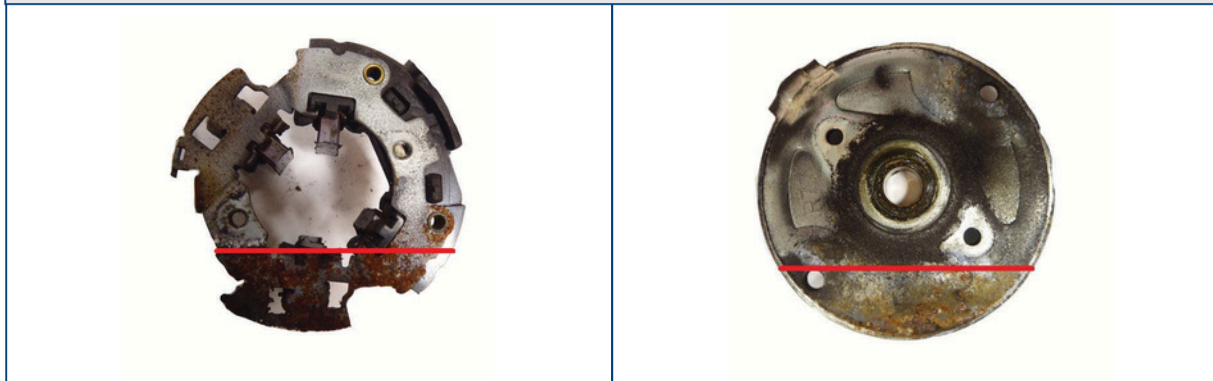
Indicating water level inside starter

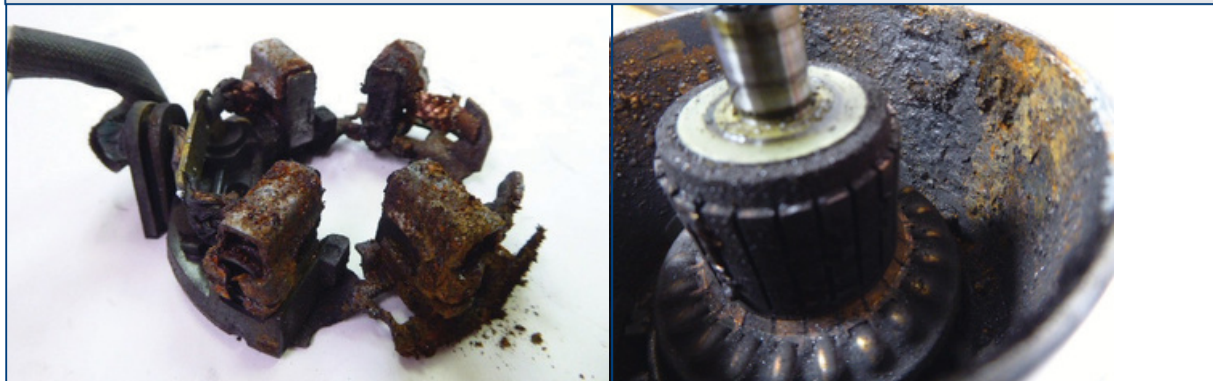
Brush holder is heavily corroded

Heavily corroded commutator and armature

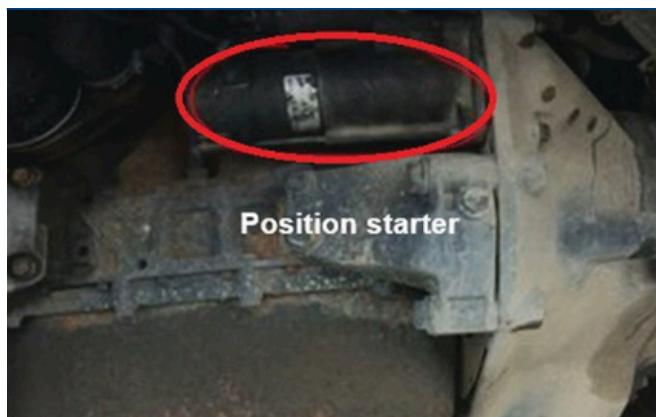
The starter is located at the left side of the engine and is facing in the driving direction of the vehicle. When the lower engine protection cover is missing, damaged or modified, during rainy periods or driving through (big) puddles of water, high amounts of splash water will cause the starter to take water inside more than it can drain via the drain holes. These high quantities of water is the root cause of heavy corrosion inside the starter motor, as shown in the pictures. Also, the use of high-pressure water cleaners can cause water ingress in the starter.
