Procedure to reset the clutch linkage

Edition N°1. Mercedes-Benz Actros MP2 / MP3 with EPS / EAS (PN: 827497 – 827498)

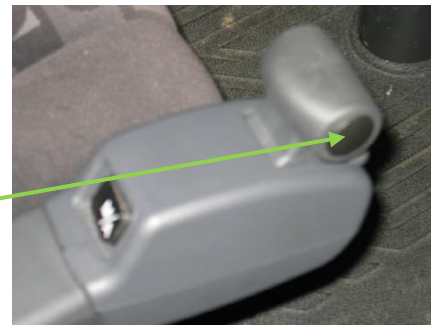
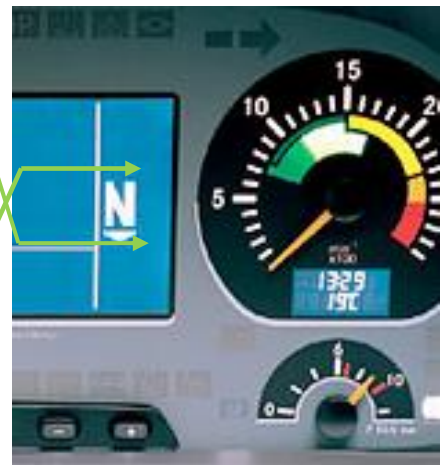
3. Press the button on right side of the gear lever (neutral) with the left hand and remain pressed continuously during all the reset process.
4. Switch on the engine with the right hand.

- ⇒ A long sound signal starts
 - ⇒ On the EPS screen (on the dashboard) the two arrows flicker, each of them always two time in alternation.
 - ⇒ Around 3 seconds after the switch on, perception of an movement on the gear lever. (The mechanical noise is not to confuse with the gearbox noise)

7. The letter "N" (Neutral) of the EPS screen switches on
 - ⇒ The reset process is finished, the clutch pedal (except EAS) and the button on right side of the gear lever (neutral) can be released.
