Technical *data*

**CT 939 K2/K3 timing belt kit, used for example in:
VW / Audi 2.5 TDI 5 cyl.**

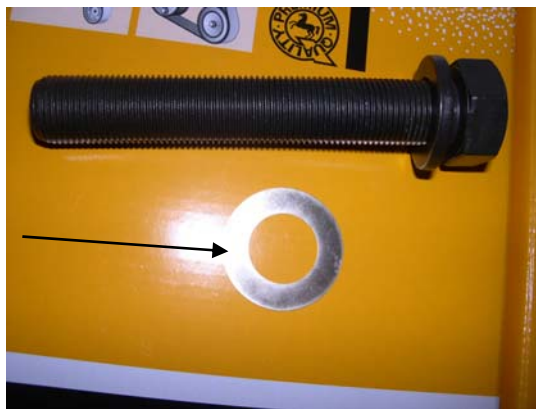
**Fig. 1
Washer**

In accordance with the updated equipment status, the timing belt kit contains a thin washer (diamond-coated) that was not previously installed in the vehicle.
