Technical *Info*

Installation tips: Renault Mégane Scenic 1,9 dti

The engine in the Renault Mégane Scenic 1,9 dti was installed in large numbers. An easily understandable installation guide is available to ensure that the belt change proceeds as smoothly as possible.

The engine code found on the metal plate on the engine block is a big help in identifying the vehicle. It reads F9 Q A 734.

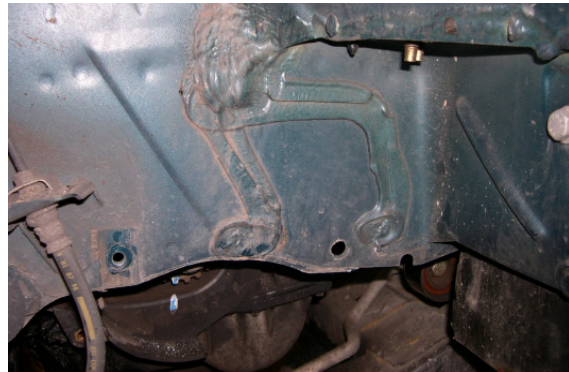
Fig. 1
Picture: ContiTech

If the vehicle is jacked up and supported, the lower, right-hand wheelhouse/engine covering can be removed (**Fig. 1**).

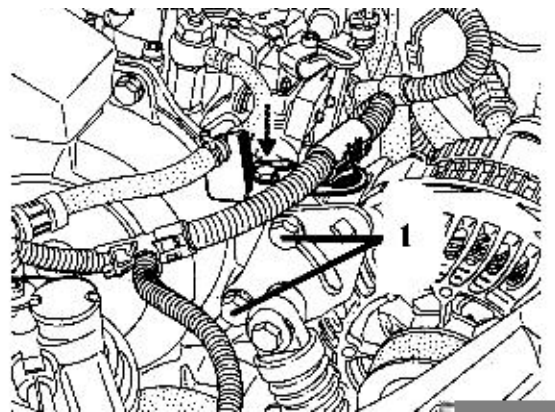
Fig. 2 Quelle: Eurotax
Picture: ContiTech

The next step is to loosen the V-ribbed belt tensioner and remove the V-ribbed belt (**Fig. 2**).

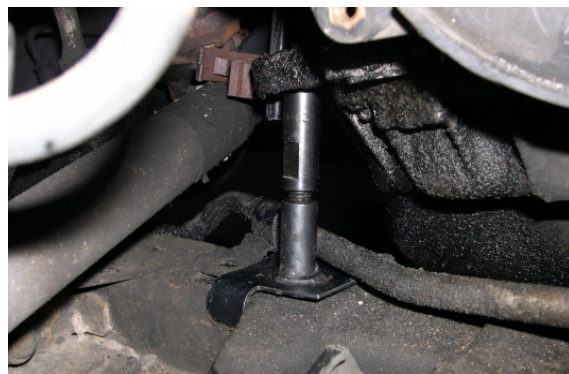
Fig. 3
Picture: ContiTech

Using the universal engine strut the engine is now suspended above. It's better to render the engine stationary by positioning support pins on its lower right end between the engine sump and the front-axle body. In this way there's more freedom of movement at the top (**Fig. 3**).

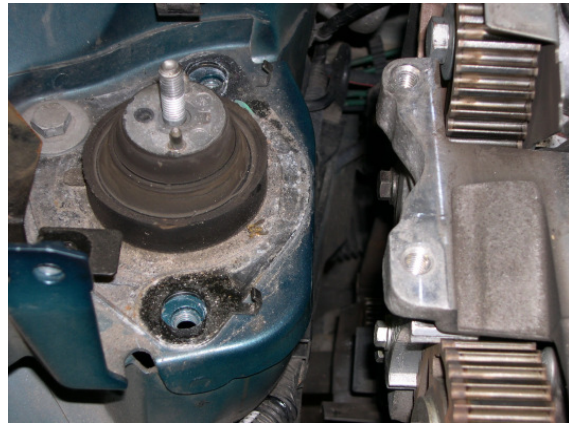
Fig. 4
Picture: ContiTech

The mechanic can now remove the engine mount at the upper right. It is now impossible for the engine to tip downwards as it has been supported accordingly (**Fig. 4**).

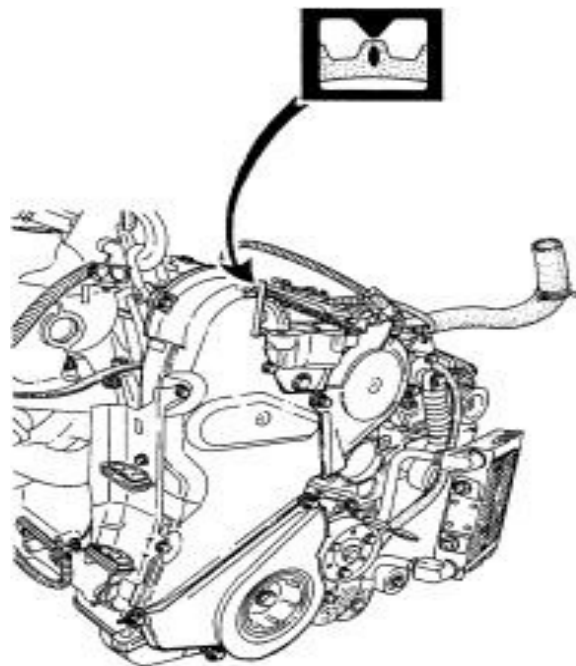
Fig. 5 Quelle: Eurotax
Picture: ContiTech

The crankshaft is now turned by hand in the running direction of the engine (in this case to the right) until the timing marks on the camshaft gear wheel are aligned with the marks on the camshaft cover (**Fig. 5**).

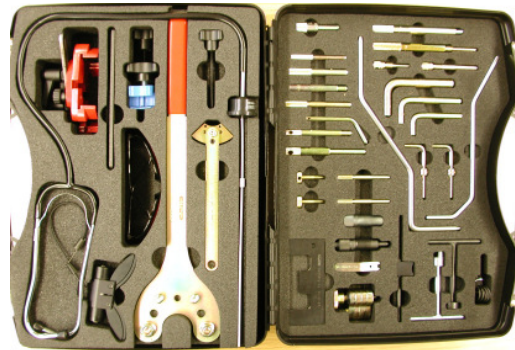
Fig. 6
Picture: ContiTech

The flywheel is blocked with the engine peg mandrel no. 1054. Now the mechanic checks to see if the mandrel is seated okay. This can be done by trying to turn the engine by hand. One'll also find a corresponding mandrel in the new special tool chest from the ContiTech Power Transmission Group, hinting at a way to further simplify the work (Fig. 6 + 7).

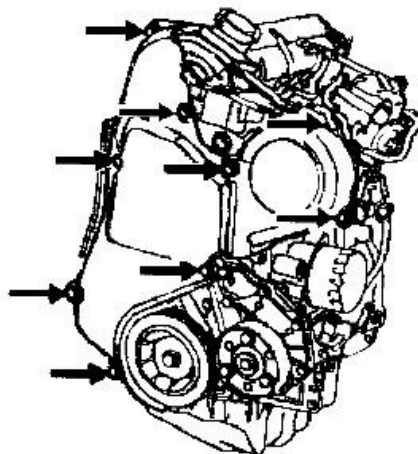
Fig. 8 Quelle: Eurotax
Picture: ContiTech

The mechanic loosens the vibration damper and the belt pulley on the crankshaft and removes them. After this the lower paneling can be loosened and removed and fix the injection pump impeller using the engine 1317 tool (Fig. 8).

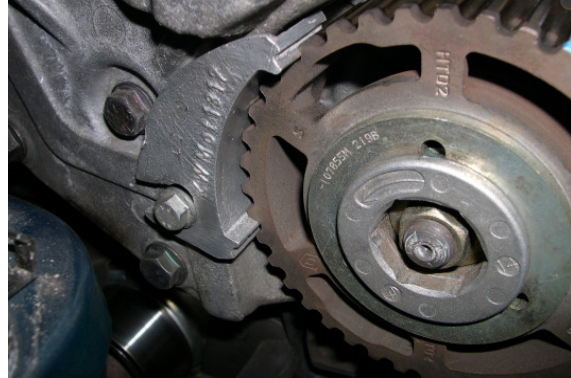
Fig. 9
Picture: ContiTech

Now the mechanic loosens the center fixation of the tensioner pulley, removes the timing belt and turns a M6 x 45 mm screw into the paneling from behind until it abuts. Now the tensioner pulley can be removed. For the subsequent installation it helps if the crankshaft gear and the on the injection pump gear are additionally marked (9+10+11).

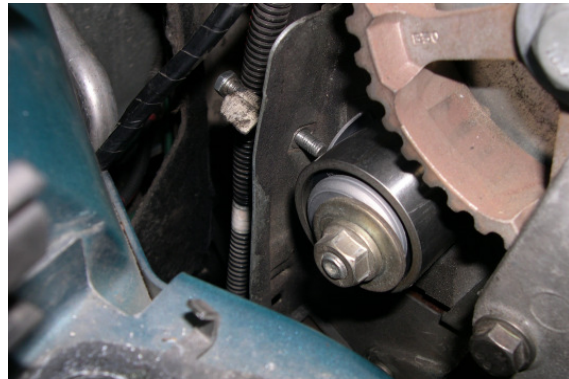
Fig. 12
Picture: ContiTech

The idler pulley can be removed with the help of a quarter-inch cap wrench. If the bolt is hard to turn a bottoming tap will very definitely have to be used, because afterwards during installation the bolt will have to be set out of eye contact (**Fig. 12**).

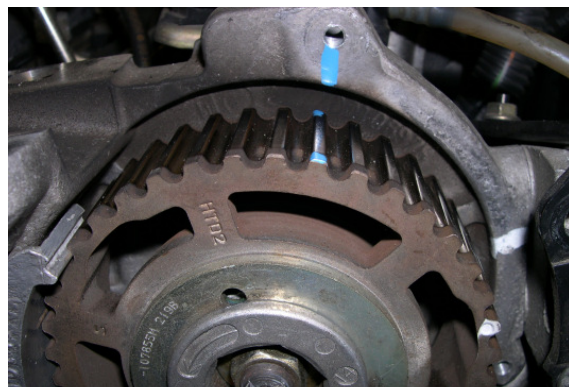
Fig. 11
Picture: ContiTech

The new tensioner pulley and the idler pulley are installed. The tensioner pulley attachment should first be installed only finger tight. The mechanic lays the timing belt in place working toward the left and positions the ignition points to align with the marks (**10+11+13**).

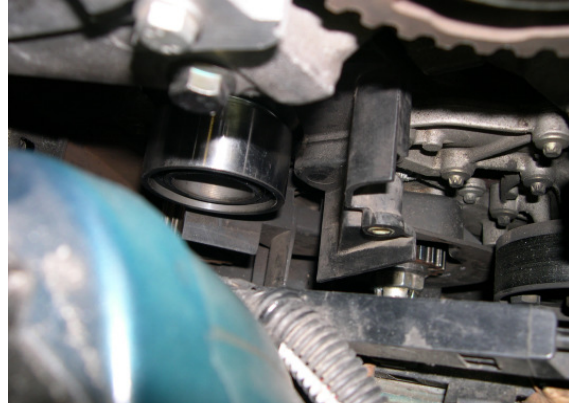
Fig. 14
Picture: ContiTech

Here as well it is a good idea to additionally mark the inner side with the crankshaft marks (Fig. 14).

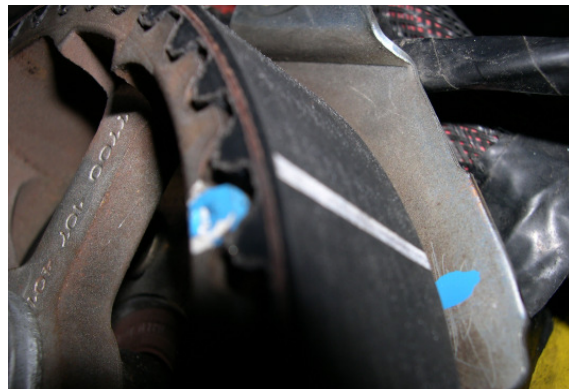
Fig. 15
Picture: ContiTech

The timing belt measuring head on the ContiTech belt tensioner is now mounted in accordance with the instructions underneath the tensioner pulley and the timing belt tightened (Fig. 15).

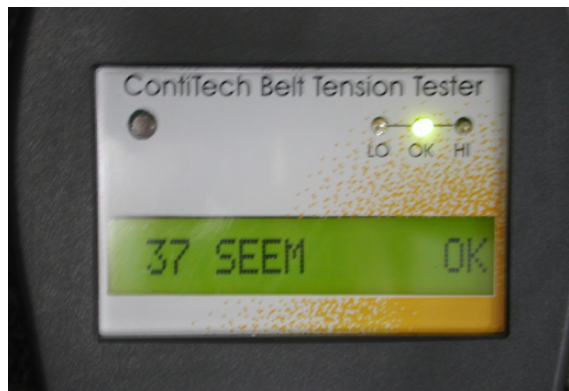
Fig. 16
Picture: ContiTech

The mechanic now removes the locating pin and the locking jaws. The timing belt is then slowly tightened around the tensioner pulley by means of the M6 bolt set from behind until the belt tensioner tester indicates 42 SEEM. The measuring head is then removed and the drive manually rotated at least two complete cycles. A further measurement is required after pressing down vigorously on the belt at the measuring point. A reading of 37 SEEM must be obtained (Fig. 16).

If this value is not obtained, the tensioning procedure must be repeated.

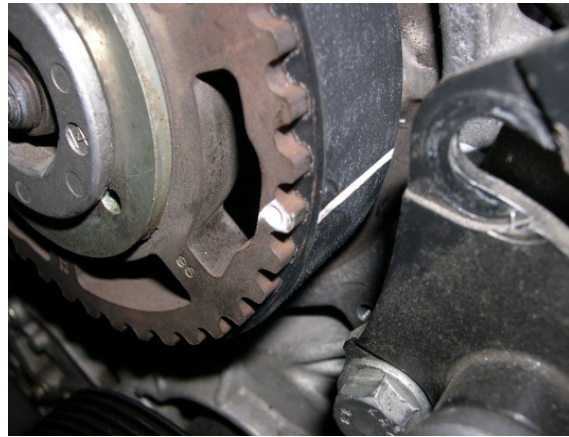
Fig. 17
Picture: ContiTech

The partially tensioned tools can easily be removed by means of slight rotational movements of the belt drive affected with a wrench (**Fig. 17**).

The mechanic then tightens the tension pulley with 50 Nm. One shouldn't forget to remove the M6 bolt. The drive pulley (20 Nm + 115°) and the multiple V-ribbed belt are reinstalled, the tensioning device is appropriately tightened. Afterwards the engine suspension has to be installed at the upper right and the retaining pin on the front axle removed.

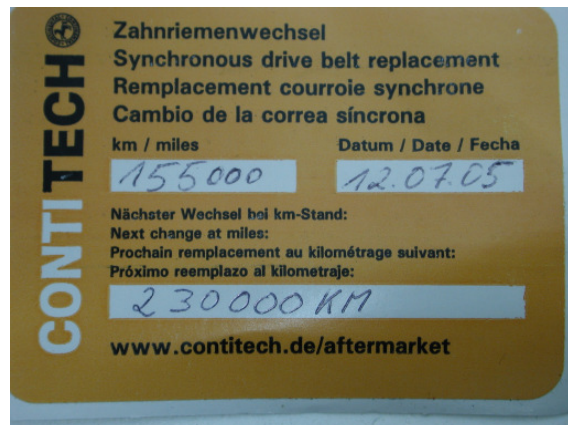
Fig. 18
Picture: ContiTech

The mechanic now replaces the rest of the paneling and puts the wheelhouse liner back in place. At this point it is important to check that all the components are tightly in place and to make sure that all locking tools have been removed. Now a trial run should be carried out to see if the engine starts okay. After warmup, the engine should be checked for any abnormal noises (**Fig. 18**).
