Fitting instruction for tensioning pulley from CT1028K3/WP1-5 for various VW, Audi, Ford, Skoda, Seat 1.9 TDI PD engines

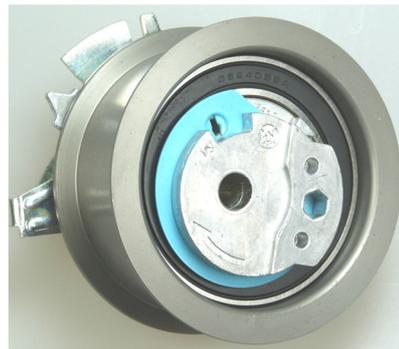
Fig. 2
Tensioning pulley
V55739

The fixing stud is used to move the still fitted tensioning pulley completely back so that the belt can be removed with the tension reduced as far as possible. This is merely a mechanical locking aid for the front eccentric plate in order to position the tensioning pulley in its maximum "loose" position.

The fixing stud can be inserted into the pulley again at any time since this does not trigger any function (pretension etc.) inside the pulley.
