# Technical *data*

CT 939 K2/K3 & CT1120K1 timing belt kit, used for example in:  
VW / Audi 2.5 TDI 5 cyl.

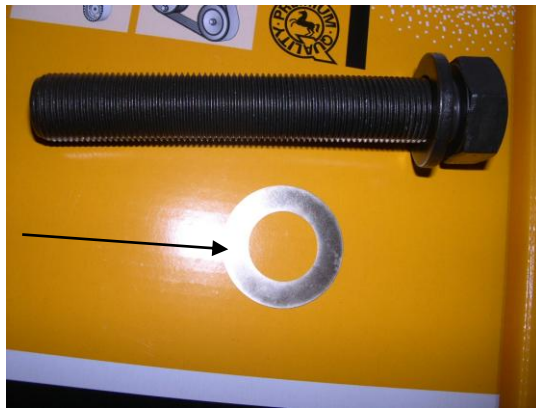
**Fig. 1  
Washer**

In accordance with the updated equipment status, the timing belt kit contains a thin washer (diamond-coated) that was not previously installed in the vehicle.

According to the VW/Audi catalog, this special washer (4) is to be installed between the crankshaft drive wheel (3) and the torsional vibration damper (5). This is intended to improve the co-efficient of friction.
