## MEYLE-ORIGINAL ball joint repair kit: All parts easily accessible, wear and tear reduced to a minimum.

to fit Peugeot 407, 508 | Citroën C5, C6

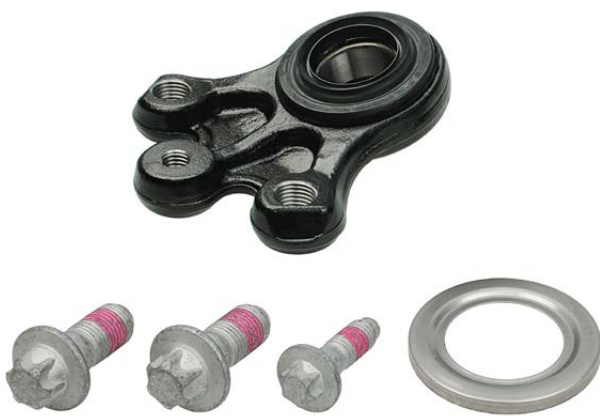
**MEYLE no. 11-16 010 0018/S**  
Short no. MCX0428

- 11-16 010 0018/S, Short no. MCX0428 (set with no guiding joint )
- 11-16 010 0019, Short no. MCX0189 (set with guiding joint)
