SWAG 50 94 5777

Ford Mondeo 07 / S-Max 06 / Galaxy 06 with 2.0 TDCi engine

DPF Pressure Hose

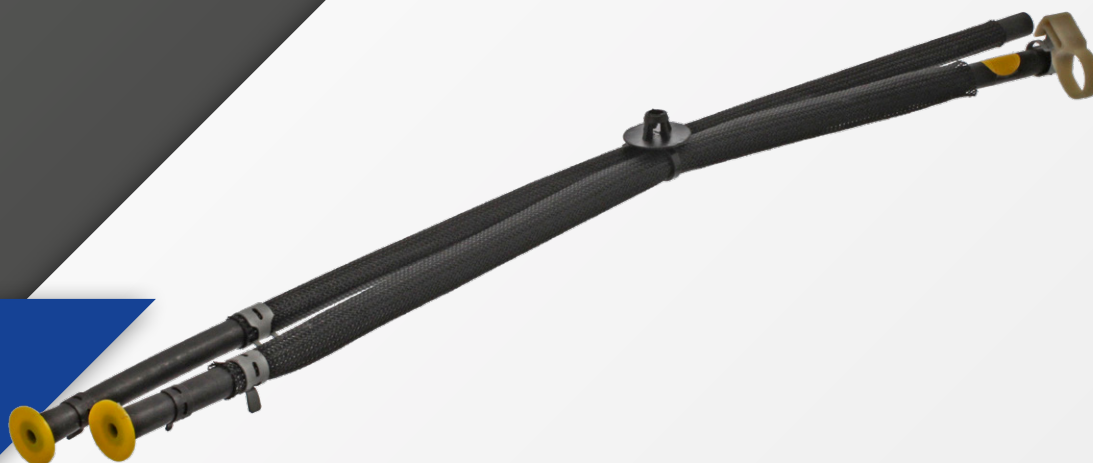
In the Ford models mentioned above, a pressure hose which routes the exhaust gas pressure to a differential pressure sensor is located on the DPF. If the differential pressure upstream and downstream of the filter is too high, this is a sign that the filter is saturated and needs replacing.

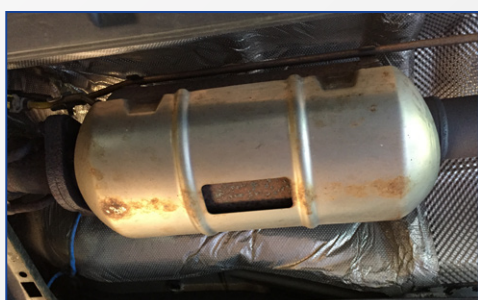
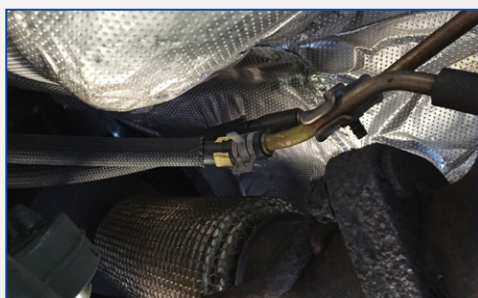
It may be that the pressure hose is blocked or has been scorched by the high temperatures, causing it to leak. As a result, the pressure actually prevailing at the differential pressure sensor is transmitted incorrectly or not at all. In this case, the engine control unit receives incorrect information and passes it on to the driver via the warning light.

Check the lines and hoses of the diesel particulate filter or sensor before carrying out a costly replacement.

The problem is often remedied simply by replacing the pressure hose. This saves the vehicle owner an expensive repair.
