SWAG 62 94 7770

Citroen, Ford, Mazda, Peugeot, Suzuki
and Toyota various models

Radiator Hose

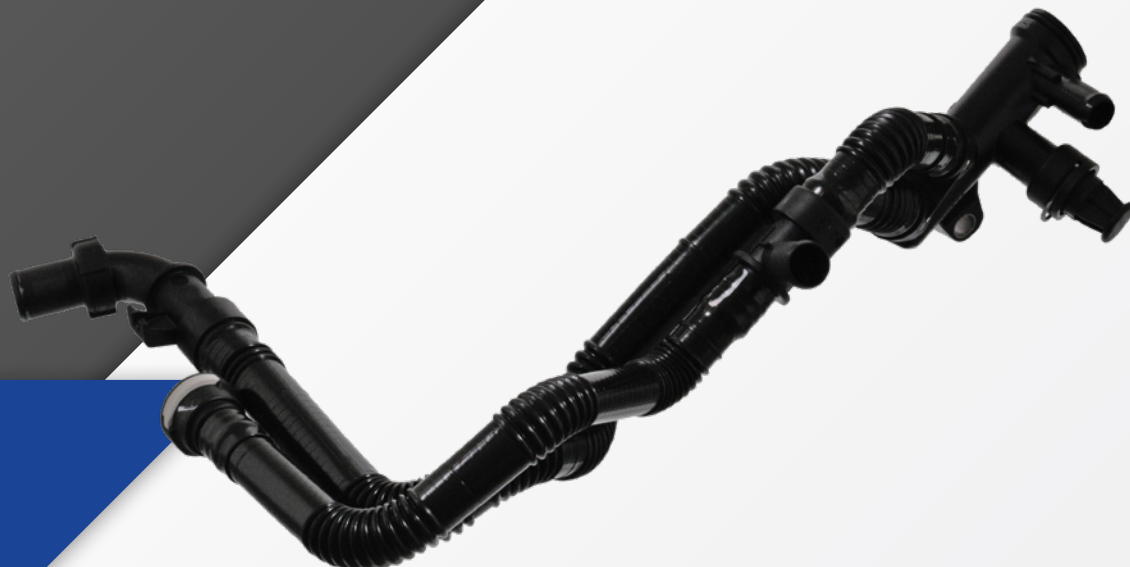
During the scheduled maintenance for replacing the timing belt and water pump, it will be required that the cooling system be drained. This requires the removal and refitting of the cooling system hoses. The brittle plastic quick connectors and joints can fracture which can cause the coolant to leak.

High temperatures and prolonged exposure to fluids can cause the rubber of the coolant hose to become soft and expand which can lead to hose failure. The plastic connectors, in turn, become brittle and are susceptible to breaking due to engine vibration and the stresses of circulating coolant. The quick connectors can also fail when the hoses are removed during cooling system maintenance.

SWAG recommends carrying out a thorough check of the cooling system hoses and plastic connectors for signs of damage when removing and installing a timing belt system and a water pump. Due to the location of the plastic connectors of this coolant hose in relation to the water pump, removal and installation is required during the replacement of the water pump which can lead to fracture damage occurring around the plastic connectors. It is recommended that this coolant hose be replaced as preventive maintenance.
