SWAG 40 02 0025

to fit:
 Vauxhall Corsa B, Tigra A,
 Astra F 1.4 16V and 1.6 16V,
 also Vectra B 1.6 16V and 1.8 16V

Timing belt kit

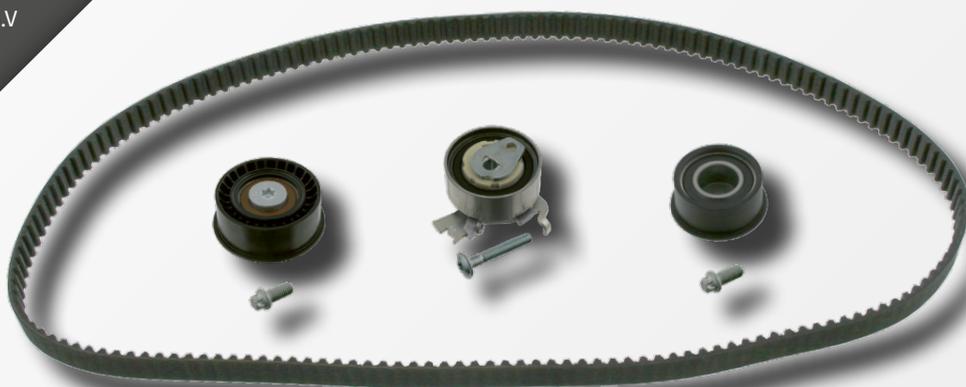
The timing belt can break.

The design of the belt pulley has been changed by the vehicle manufacturer. The slightly raised section of the old belt pulley (refer to picture 1) can cause a faster deterioration of the timing belt edge. This causes the timing belt to move and be prematurely torn, leading to serious engine damage.

SWAG recommends: before fitting the timing belt kit SWAG 40 02 0025, check for a raised part of the belt pulley and, if necessary, replace with the new version (refer to picture 2) (Vauxhall plan 5614 430). The new belt pulley will fit correctly to the timing belt, thereby guaranteeing a longer life span.

Please note: when you replace the belt pulley, the crankshaft gear (refer to picture 3) (Vauxhall 0614 546) and the stretch bolt (refer to picture 4) (0614 932 Torx) should also be replaced.

In any case, however, you must replace the water pump!
