# SWAG 30 10 8187

To fit: Various Volkswagen, Audi, SEAT & Škoda models

## Heat Exchanger for heating system

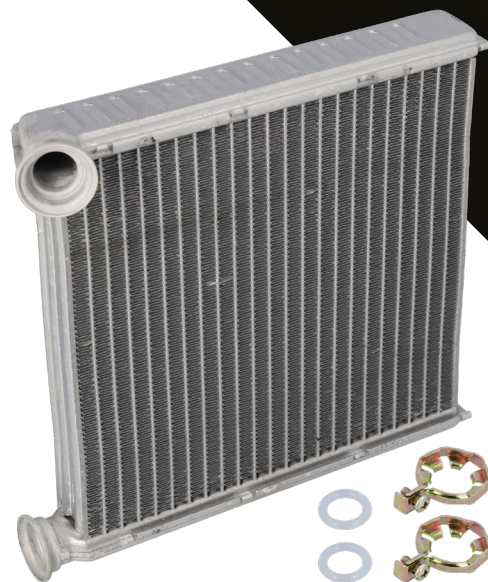
Inefficient interior heating may present with symptoms such as low heat output on one side of the vehicle, one side being noticeably colder than the other, or a complete lack of heat on either side.

Silicates have been added to the coolant to protect the aluminium components of the cooling system. Over time, these silicates deplete and lose their effectiveness in corrosion protection. This would not usually be a problem if the coolant was replaced at the recommended intervals.

Some Volkswagen Group vehicles have a silicate bag inside the coolant expansion tank – these tanks have the words 'MIT SILIKAT' on the outside. These silicate beads are designed to leach into the coolant over time to keep the corrosion protection at an acceptable level.

However, heating problems occur when these silicate beads migrate from the coolant tank to the heat exchanger, blocking it which in turn results in a loss of heating efficiency.

Drain and flush the coolant system by disconnecting hoses at various points to remove the old coolant and eliminate any contamination from both the heating and cooling circuits. Remove the blocked heat exchanger from the interior heater unit. Install the new heat exchanger with new seals and clamps. It is also recommended to replace the cooling system expansion tank with one that does not have a silicate bag inside.

Fill the cooling system with a fresh mix of concentrated G12evo coolant and distilled water or ready-mixed G12evo. Vacuum bleed the cooling system, then carry out the bleeding process using a suitable diagnostic tool to run the additional electric water pumps to ensure all excess air is expelled.

Finally, start the engine, warm up to operating temperature, check for any coolant leaks and test the heating system to ensure it is functioning correctly.
