SWAG 33 10 5996

To fit: Toyota Echo and Yaris 1.

Axle Beam Mount

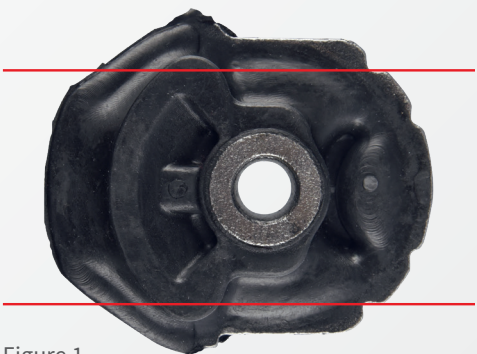
Figure 1

To remove the axle beam mounting, first mark the alignment of the bush to the axle. (Fig.1)

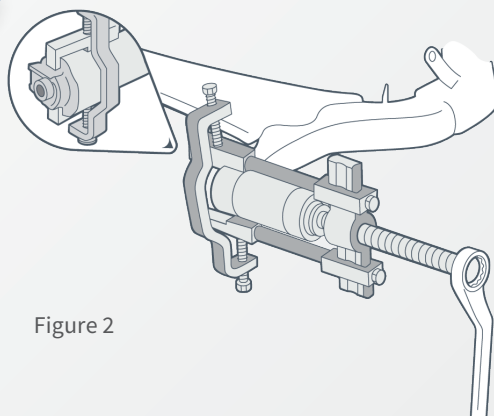
Figure 2

Clean all mating surfaces so that they are free of corrosion and road debris. Align the new bush to ensure the correct orientation before pressing the new mounting into the axle, repeat for the other side. (Fig.2)

With the new axle beam mountings replaced, refit the complete axle to the vehicle including all fixings, suspension and brake components. Tighten the axle beam mounting bolts to 82 Nm with the rear suspension in the neutral position.

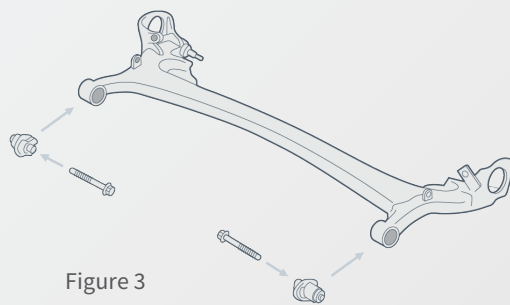
Figure 3

Use a suitable chisel and hammer to bend the two portions of the inner flat side of the bush, then using a suitable pressing tool, push the bush out of the axle mounting. (Fig.3)
