SWAG 33 10 9143, 62 94 9560, 62 94 7947

Various Peugeot/Citroën/DS, Vauxhall/Opel and Toyota models fitted with the 1.2-litre three-cylinder engine

Timing Belt

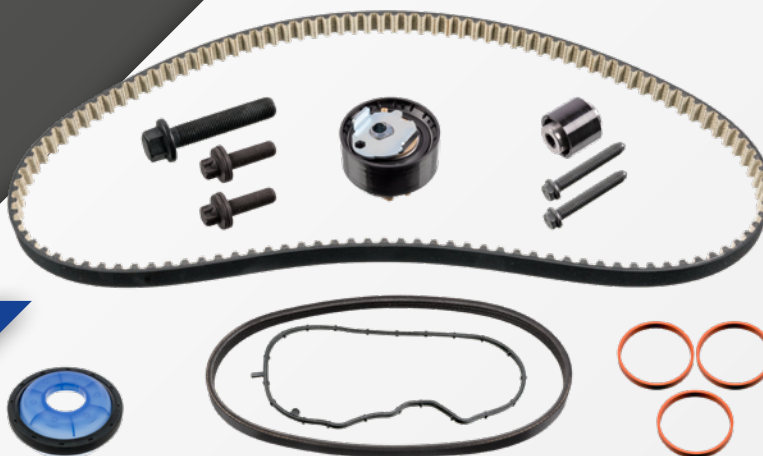
Premature deterioration of the timing belt material can lead to the loss of engine oil pressure and the oil pressure warning lamp showing as illuminated. In addition, fault codes P15A0, P15A1 and P15A8 will be present and logged in the engine control unit.

The 1.2-litre PSA group engine is fitted with a timing belt that runs in oil. In some cases the timing belt material deteriorates during service - leading to a blockage of the engine oil ways. This can cause severe engine damage and/or loss of vacuum assistance to the braking system.
