To fit: Ford B-Max 2012-17, Ecosport 2012-,  
Fiesta IV 2008-17, KA+ 16-

## Coolant Expansion Tank

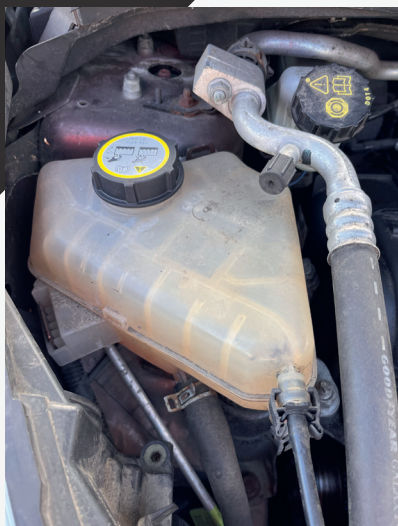
Figure 1

Due to thermal stress and engine drive cycles with dramatic changes in temperature, the coolant expansion tank becomes brittle and discolours, leading to cracks appearing in the plastic, sporadically leaking coolant. Under certain conditions this can result in hot coolant being forced under pressure over the engine, soaking the ignition leads and spark plugs with coolant. This leads to the engine misfiring.

Check the condition of the coolant expansion tank. If it has discoloured (Fig.1) then the plastic has become brittle with age and could be at risk of cracking and leaking. If found in this condition during routine maintenance replacement is advised before any coolant loss issues occur.

To fit a new coolant expansion tank it may be necessary, depending on the model, to remove the headlamp for ease of access. Unclip all hoses and pipes, drain the excess coolant, then free the expansion tank from the metal tags securing it to the inner wing.

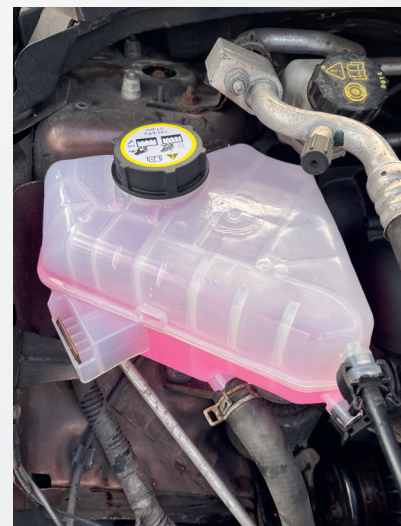
Figure 2

Replace with new SWAG Expansion Tank 33 11 0655 and Cap 99 10 5933, clip into place and refit all hoses and pipes. Top up the cooling system with fresh coolant mixture. (Fig.2) Refit the headlamp as required.

Start engine, check for any leaks and the smooth running of the engine.
