# SWAG 33 11 2224

To fit: BMW 2 Series (F45, 46), X1 (F48), X2 (F39), MINI (F54, 55, 56, 57)

## Thermostat Housing with sealing ring

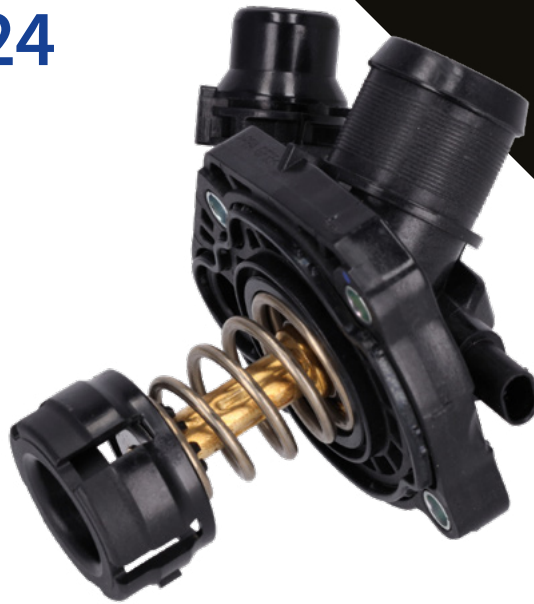
Coolant loss from water pump housing.

Due to constant cycles of hot and cold the plastic housing of this thermostat becomes distorted. This results in coolant leaking from the water pump housing.

Pressure test the cooling system to identify that the thermostat housing is causing the coolant leak. Drain the coolant then remove the water pump and inspect.

The vehicle manufacturer only supplies the complete water pump and thermostat assembly. However, SWAG Thermostat Housing with sealing ring 33 11 2224 is available without the complete water pump, offering workshops a more sustainable and cost-effective repair solution.

Unbolt the thermostat from the water pump, clean the mating surfaces and install the new thermostat to the water pump housing, then refit to the engine. Fill the cooling system with fresh coolant, bleed any excess air from the system, then run the engine to operating temperature and check for any coolant leaks.
