Steering gear JRP1160, JRP219, JRP289, JRP739

If, following the replacement of one of the steering gears mentioned above and after setting the front and rear axles on the vehicle, the steering wheel is turned more than 45° when the wheels are in the straight-ahead position, this can only be corrected using the following working instructions.

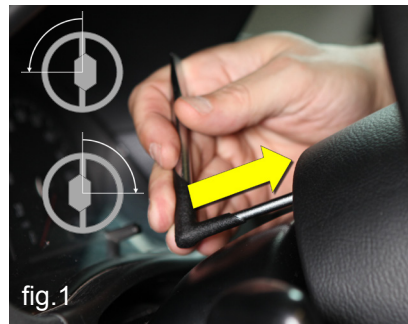
1. Move the wheels into the straight-ahead position regardless of the position of the steering wheel.
2. Measure and set the tracking of the front and rear axles in accordance with the vehicle manufacturer's guidelines.
3. Disconnect the vehicle battery.
Make sure that any required information, e.g. radio code, is available.
4. To release the retaining brackets of the airbag module, turn the steering wheel 90° to left and right as shown in fig.1 and fig.2.
5. Carefully lift the airbag module. Unlock and disconnect the plug connector (fig.3) and remove the airbag module.
Caution: Set the airbag down outside of the vehicle with the plug connector side facing downwards.
6. Move the wheels into the straight-ahead position regardless of the position of the steering wheel.

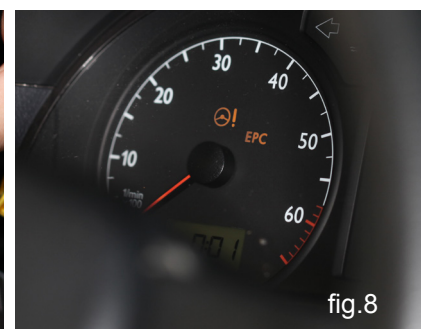
fig.8

- Connect the plug connector for the contact roller
 - Connect and lock the plug connector for the airbag module
 - Attach the airbag module. *Make sure that the module snaps into the retaining brackets.*
 - Connect the battery
11. Start the engine. The steering system and vehicle stability control warning lights (fig.8) must expire. *If one or both warning lights are still illuminated, carry out the following procedure: **With the engine running, turn the steering wheel slowly to right and left rest position until the warning lights switch off.** With this procedure the steering angle sensor is calibrated automatically.* If the lights have not switched off, reset and calibrate the system with an appropriate diagnostic tool.
