## Service Info

# Installation instruction 713 6678 20

## Additional race to protect the shaft seal

Manufacturer: Mercedes Benz

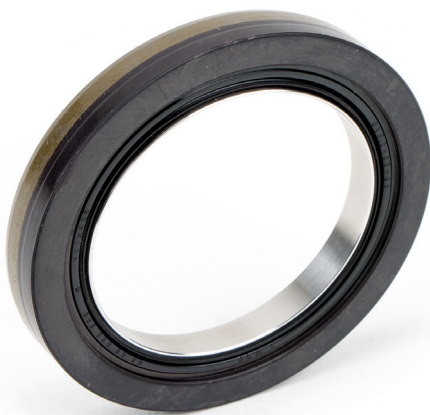
The design of the radial shaft seal from FAG WheelSet 713 6678 20 has been changed and now includes an additional sleeve (Fig. 1).

The reason behind this change is that the contact surface between the stub axle and the shaft seal can corrode over time. Moisture can penetrate into the wheel bearing as a result, thereby leading to premature failure.

Fig. 1: Radial shaft seal with additional sleeve

During installation, the new sleeve used in the radial shaft seal is slipped on over the damaged area, thereby protecting the seal lip against damage by the corroded stub axle.

The sleeve is pre-installed in the radial shaft seal. It must not be removed under any circumstances and is slipped onto the steering knuckle together with the wheel hub! When the front wheel hub is removed, the sleeve (if present) usually separates from the radial shaft seal and must be removed separately from the steering knuckle stub axle.

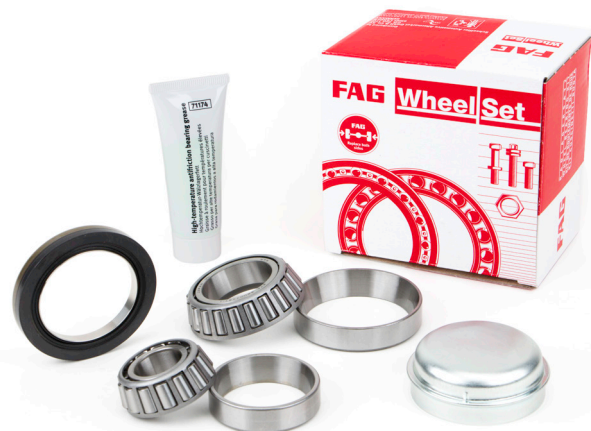
Fig. 2: FAG WheelSet 713 6678 20

The prerequisite for this repair method is that only slight corrosion is found on the stub axle after removal of the wheel hub. That area can be cleaned with conventional workshop supplies.

If the stub axle shows very heavy signs of corrosion in the seal contact area, the complete steering knuckle must be replaced.
